RE: Review of Thirteenth (13th) Re-measure of the Waterline W1A and W2A Benchmark Elevations in the Woodlands, Texas in September 2021 and Evaluation of Potential Damage to the Transmission Line along Segments W1A and W2A from Land Subsidence

ATTACHMENT A Review of W1A and W2A Benchmark Elevations

Review of Thirteenth (13th) Re-measure of the Waterline W1A and W2A Benchmark Elevations

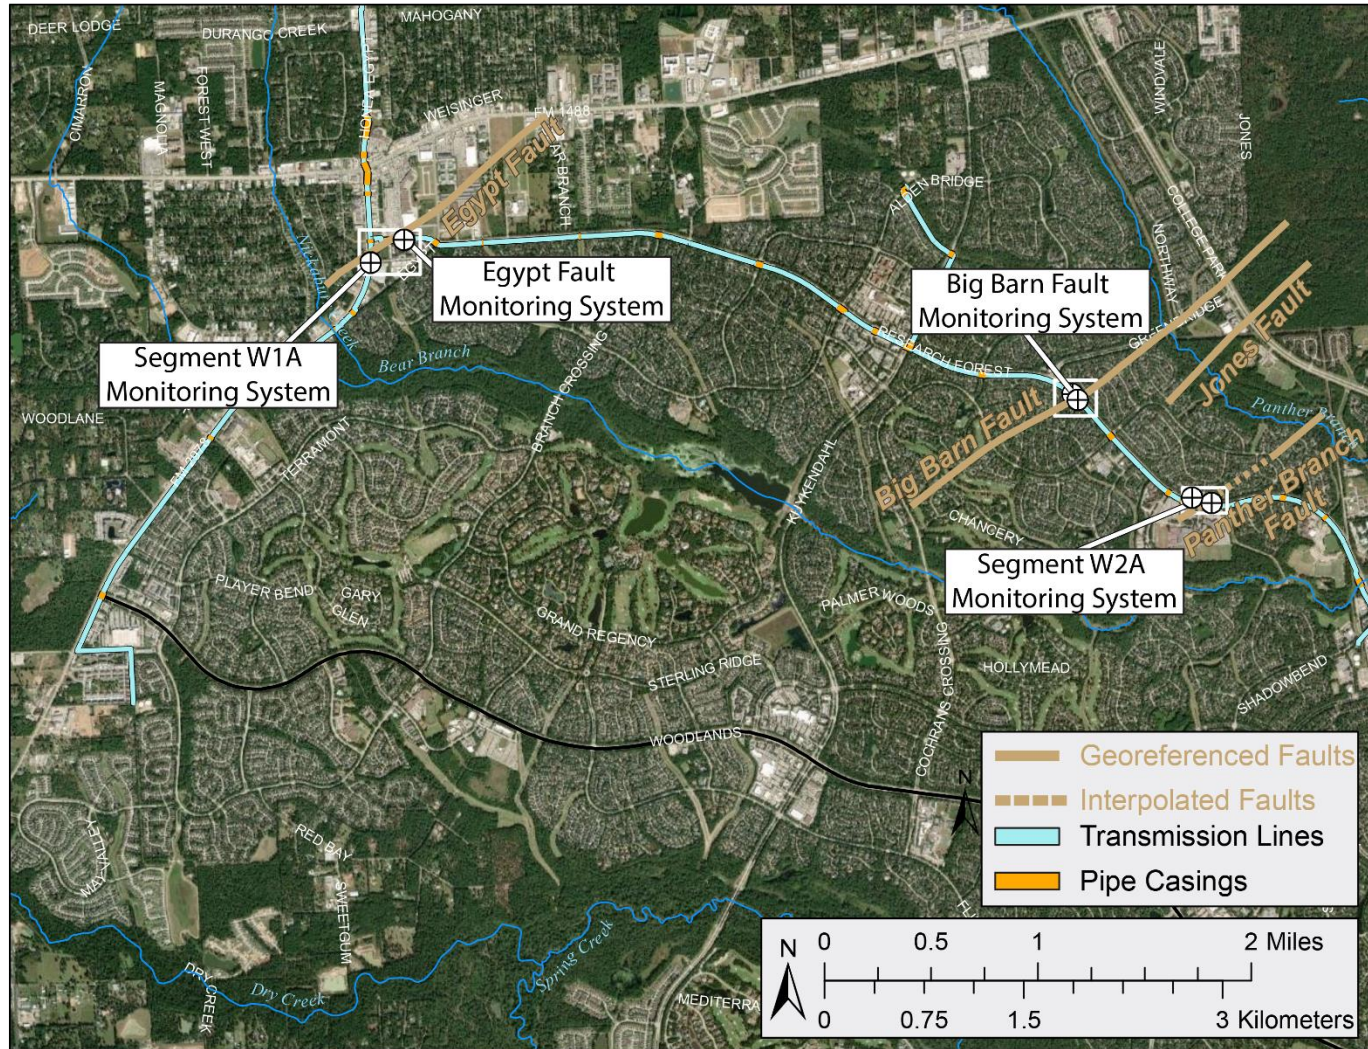
Figure 2 Satellite map showing the location of the SJRA transmission line, the fault locations mapped by Fugro (2012), and SJRA monitoring locations for benchmark elevation

Figure 2 is a satellite map that shows the SJRA transmission line and the faults that have been identified in the W1A and W2A area by Fugro (2012). The lateral extent of the Egypt fault, the Big Barn Fault, the Jones Fault, and the Panther Branch Fault mapped by Fugro (2012) are represented by the georeferenced fault lines. In their study, Fugro (2012) did not extend the Panther Branch Fault across the transmission line route. The interpolated portion of the Panther Branch Fault was mapped by INTERA based on the evaluation of the benchmark elevation for Segment W2A and scarp locations in the parking lot of The Woodlands High School. At three locations where the transmission line crosses a fault, SJRA constructed safeguards specifically designed to protect the transmission line from damage caused by land subsidence and installed benchmarks to monitor land subsidence. Because the Fugro report (2012) did not show the Panther Branch fault crossing Research Forest Drive and the planned route for the transmission line, SJRA did not construct safeguards to specifically protect the transmission lines from damage caused by land subsidence. However, in order to help investigate whether an extension of the Panther Branch Fault as mapped by the Fugro report (2012) existed along Research Forest Drive, SJRA installed the benchmarks associated with the Segment W2a Monitoring System.

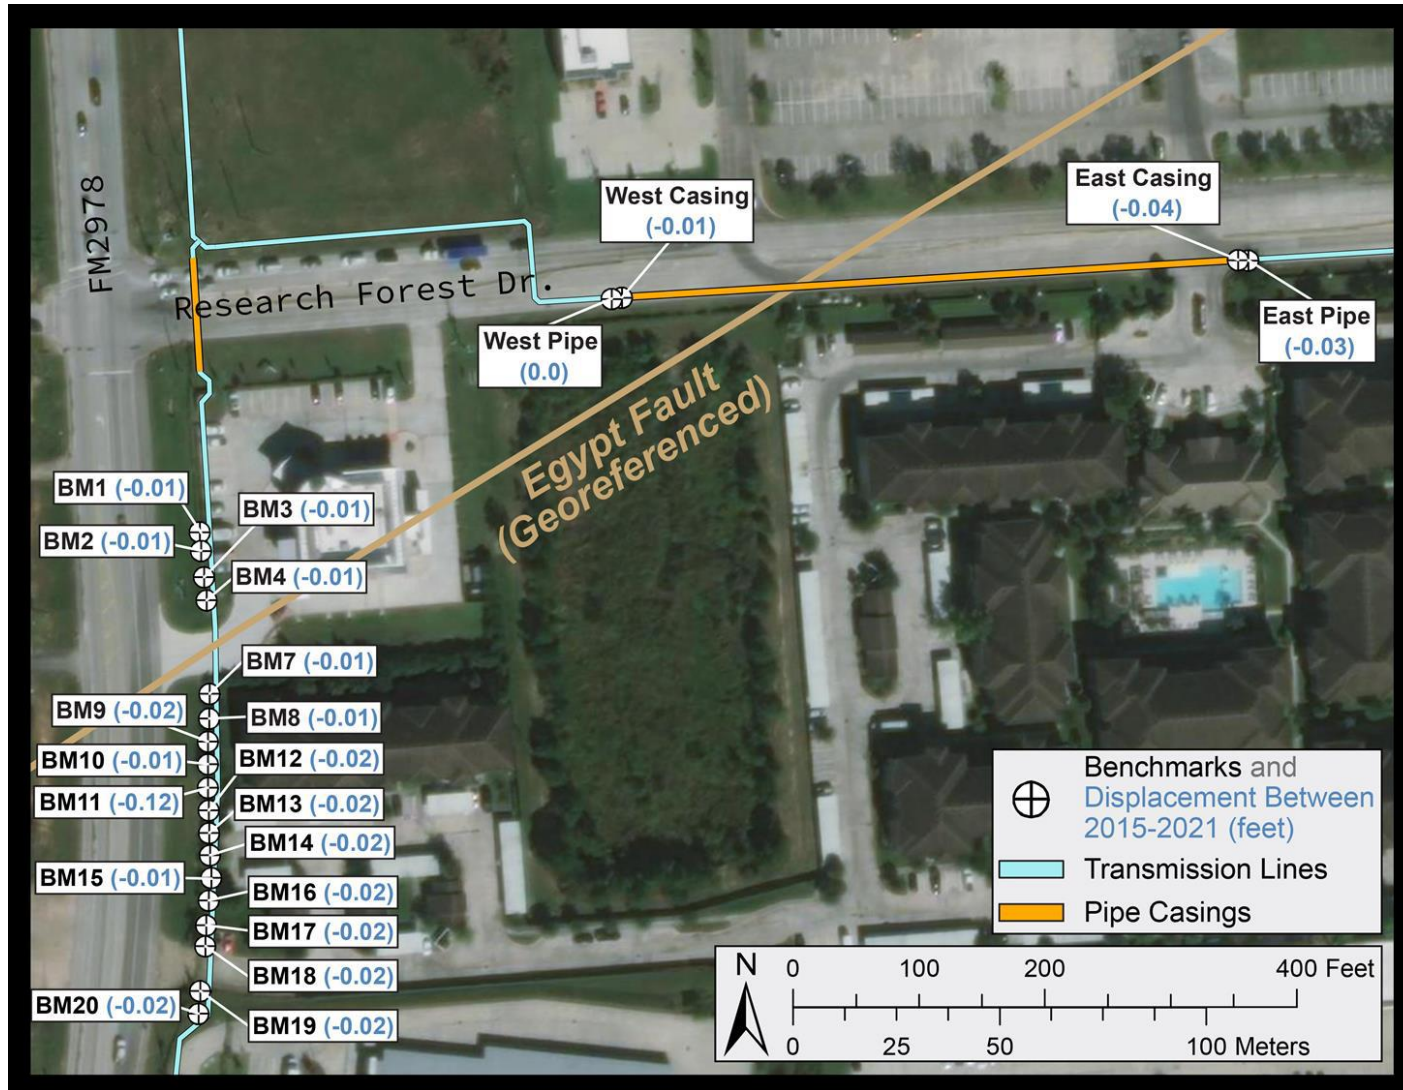
Figure 3 Satellite map showing the location where the Egypt Fault (Fugro, 2012), the W1A monitoring locations and calculated displacement from September 2015 to March 2021 and the SJRA transmission line and pipe casing.

Over the last 6.5 years, the net change in elevation for the 4 benchmarks at Egypt Monitoring System (see Table 2 and Figure 3) range between 0 and -0.04 ft and the average is -0.02 ft. The two benchmarks on the upthrown side of the fault have an average decrease of 0.005 ft in elevation whereas the two benchmarks on the downthrown side of the fault have an average decrease of 0.035 ft. Over the last 6 months, the two benchmarks on the upthrown side of the fault had an averaged a rise in elevation of 0.005 ft whereas the two benchmarks on the downthrown side of the fault had average drop in elevation of 0.005 ft. The changes in benchmark elevations that occur over both the 6 month and 6.5 year periods suggest that Egypt fault could be a contributing factor to the difference in the measured rate of elevation change, which are about 0.005 ft/year, across the transect it divides.

In the vicinity of the Egypt Fault Monitoring System, SJRA's 48-inch diameter transmission line is protected by a pipe casing along a 500-ft section that crosses over the Egypt Fault. The transmission line is constructed of steel and capable of shifting approximately 1-ft over the 500-ft interval without problems. Because of the possibility that the transmission line could eventually have a differential movement of more than 1 ft, SJRA constructed a safeguard using pipe casing. The pipe casing safeguard is designed to protect the transmission line for up to 0.25 inches of vertical movement at the fault per year over a 50-year period, or a total of 12.5 inches. The dip angle of the fault was estimated at 70 degrees. A 12.5-inch vertical movement is expected to cause the casing and pipe to bow and move horizontally up to 4-inches. The pipe and casing can deflect and "flex" with the vertical movement but a horizontal movement of 4 inches could stress the steel enough to break the joints. To protect against the horizontal movement, two expansion couplings, each of which can move up to 4 inches horizontally, were added at the pipe connections. These expansion joints allow up for 8-inches of horizontal movement. Several methods are in place to monitor the condition of the transmission pipe. One of these methods is measuring the change in elevations in the casing and pipe at the ends of the pipe casing. After 6.5 years of monitoring the differences the benchmark elevations over time are less than 0.05 ft.. Based on the information that INTERA has reviewed, INTERA concludes the transmission line is not at risk of damage from land

subsidence where it crosses the Egypt Fault along Research Forest Drive for the next 50 years if land subsidence continues at its current rate and if the SJRA safeguards work as designed.

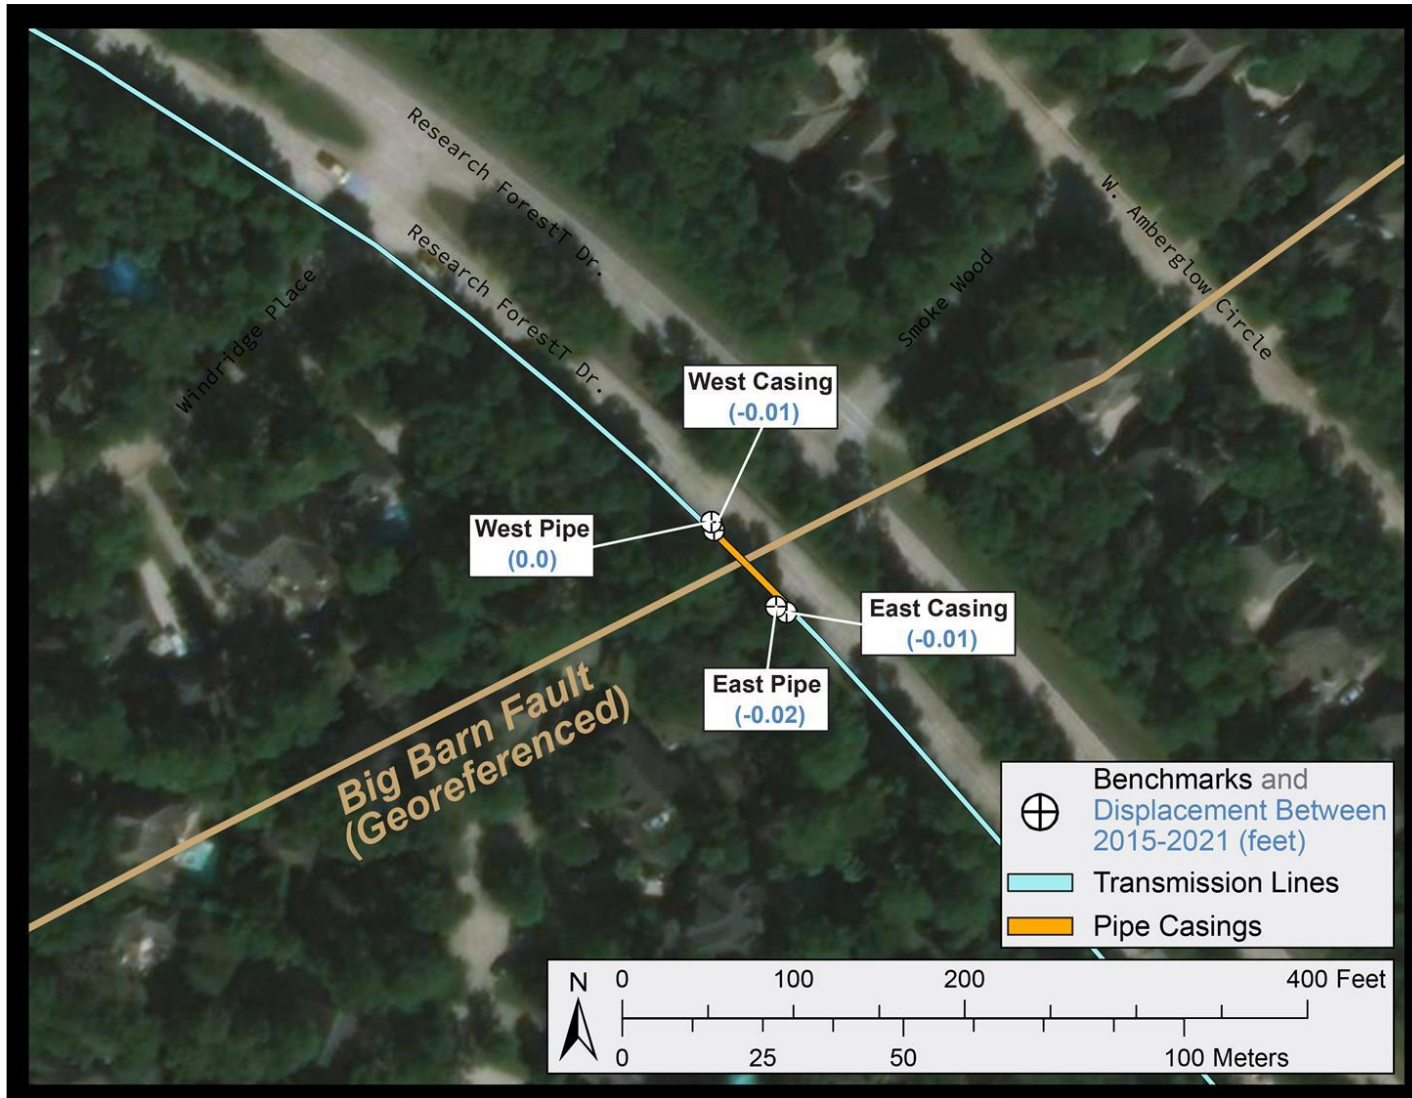
Figure 4 Satellite map showing the location the Big Barn Fault (Fugro, 2012), the Big Barn Fault Monitoring System, calculated displacement from September 2015 to March 2021, and the SJRA transmission line and pipe casing.

In Table 3 and in **Figure 4**, the 2 benchmarks that are on the downthrown side of the fault have an averaged elevation decrease that is 0.01 ft more than the two benchmarks on the upthrown side of the fault. Our interpretation of the results from the 6 month and 6.5-year intervals suggest that there is no conclusive evidence of an active fault zone between the location of the benchmarks.

INTERA has reviewed the drawings for the safeguard that SJRA has constructed for the transmission pipe at the Big Barn Fault Monitoring System. The safeguard is similar to the safeguard SJRA constructed using pipe casing for the Egypt Fault Monitoring System. The differences in the benchmark elevations at the Big Barn Fault Monitoring System over 6.5 years are less than 0.05 ft. The safeguards that SJRA have constructed are designed to handle 12.5 inches of vertical move over 50 years. Based on the information that INTERA has reviewed, INTERA concludes that the transmission line is not at risk of damage from land subsidence where it crosses the Big Barn Fault along Research Forest Drive for the next 50 years if land subsidence continues at its current rate and if the SJRA safeguards work as designed.

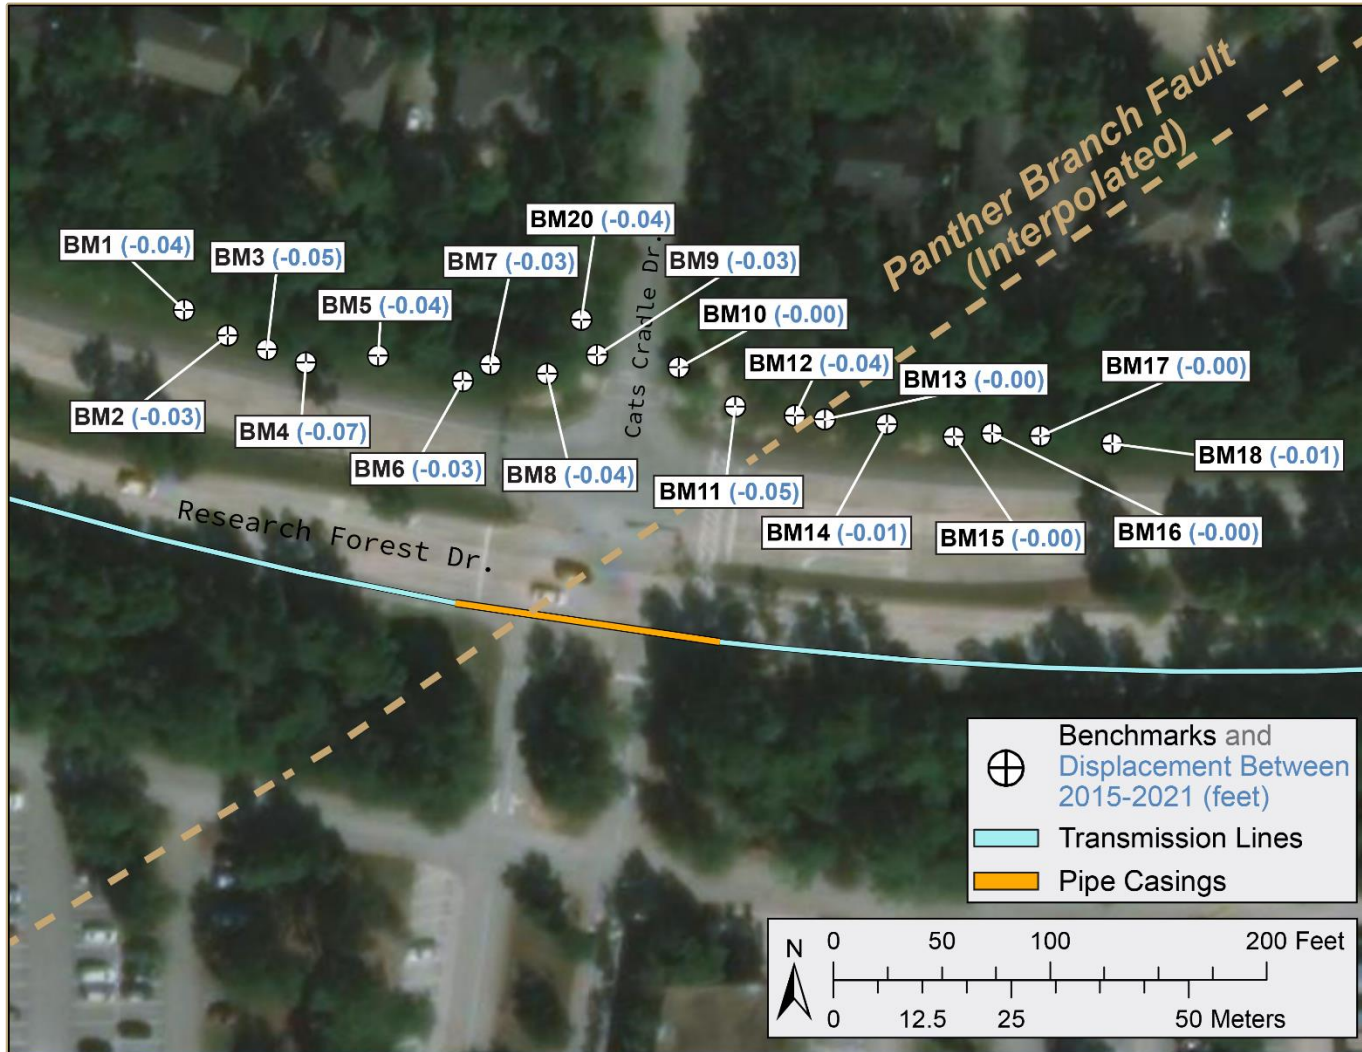
Figure 5 Satellite map showing the location the Panther Branch Fault mapped by INTERA, the Segment W2A Monitoring System, calculated displacement from September 2015 to March 2021, and the SJRA transmission line and pipe casing.

In Table 4 and in **Figure 5**, the 19 benchmarks associated with the Segment W2A Monitoring System indicate that the western portion (downthrown side) of the transect has decreased in elevation more than the eastern portion (upthrown side) of the transect. At the western benchmarks MbM-1 through MbM-12 (with MbM-10 excluded) and MbM-20, the elevation change ranged from -0.0 to -0.07 ft and averaged about -0.041 ft. At the eastern benchmarks MbM-13 through MbM-18, the elevation change ranged from -0.00 to -0.01 ft and averaged -0.004 ft. Along the W2A segment, the differences in elevation suggest that the Panther Branch Fault is located near benchmark MbM-12 and may be a one of several factors that contributes to the differences in land subsidence rates of about 0.005 ft/yr between the benchmarks located on the western and eastern portion of the W2A segment.

Because the Fugro report (2012) did not show that Panther Branch Fault crossing the transmission line, SJRA did not construct specific safeguards to protect the transmission line from differential subsidence associated with the Panther Branch Fault. However, based on the location of the Panther Branch Fault mapped by INTERA in Figure 5, the Panther Branch Fault crosses a section of the transmission line that has been provided additional protection by being enclosed in pipe casing. Per discussion with SJRA, SJRA plans to continue to monitor any subsidence that is observed from the Segment W2A Monitoring System and discuss with transmission line experts if significant movement is observed.
