April 29, 2022

**RE: Review of Fourteenth (14<sup>th</sup>) Re-measure of Elevations at Monitoring Benchmarks and Monitoring Points Along the Water Line Segments W1A and W2A in the Woodlands, Texas and Evaluation of Potential Damage to the Water Line along Segments W1A and W2A from Land Subsidence**

### Review of Fourteenth (14th) Re-measure of the Elevations at Monitoring Points and Monitoring Benchmarks along Water Line Segments W1A and W2A

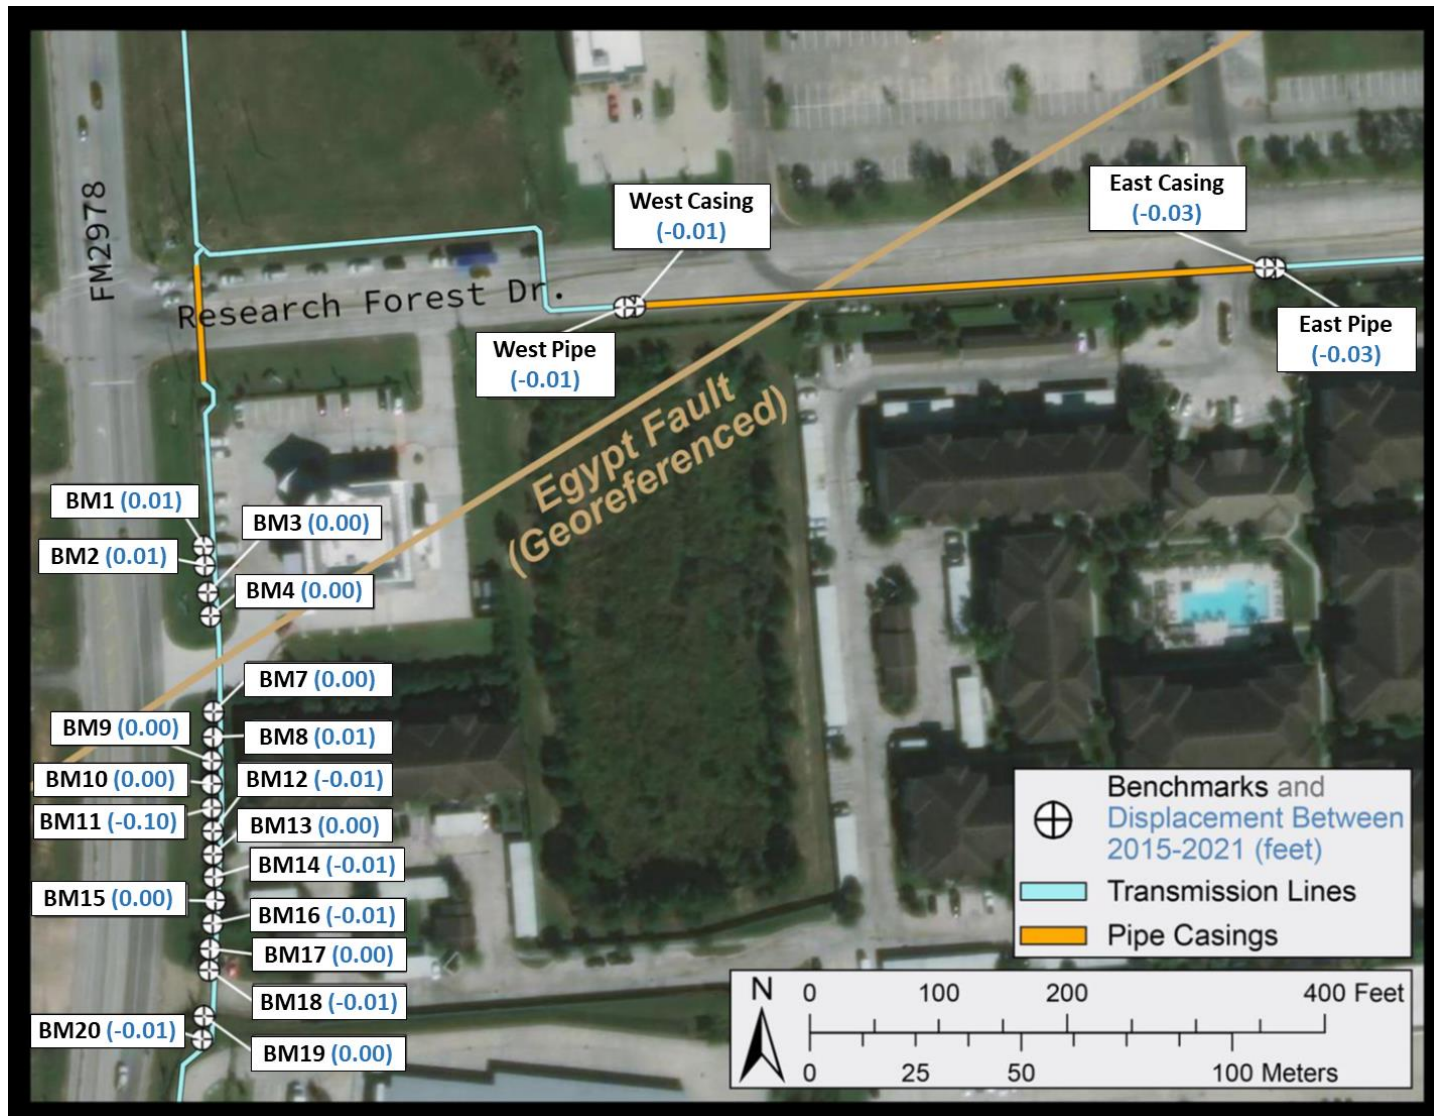
Along the W1A segment where four monitoring points straddle the Egypt Fault (Figure 3), the changes in the elevations from March 2015 to March 2022 indicate that a greater decrease in land elevation occurred on the downthrown side than on the upthrown side of the Egypt Fault. Over the 7-year period from 2015 to 2022, the land surface on downthrown side of the Egypt Fault decreased 0.02 ft in elevation relative to the upthrown side of the Egypt Fault. The 0.02 ft decrease over a 7-year period translates into an average subsidence rate of approximately 0.003 feet per year (ft/year).

Along the W1A segment where 18 monitoring benchmarks are located FM 2978 (Figure 3), the changes in monitoring benchmark elevations from March 2015 to March 2022 indicate that a greater decrease in land elevation has occurred on the downthrown side than on the upthrown side of the Egypt Fault. Over the 7-year period from 2015 to 2022, the land surface on downthrown side of the Egypt Fault decreased 0.008 ft in elevation relative to the upthrown side of the Egypt Fault. The 0.008 decrease in land elevation over a 7-year period translates into average subsidence rate of approximately 0.001 feet per year (ft/year).

The decrease of 0.10 ft in elevation at monitoring benchmark MbM-11 is an outlier when compared to other measured differences in elevations along FM 2798. The significantly higher amount of decrease elevation at MbM-11 is attributed to the monitoring benchmark being located in a narrow zone of highly disturbed soil in the downthrown fault blocks. The 0.10 ft decrease in elevation change is likely caused by the slow, progressing compaction of soil. The elevation changes at the remaining 13 monitoring benchmarks that include MbM-7 through MbM-20 (with MbM-11 excluded) on the downthrown side of the Egypt Fault average a decrease of 0.003 in elevation from March 2015 to March 2022. Across the monitoring benchmarks on the upthrown side of the Egypt Fault along FM 2798, the monitoring benchmarks MbM-1 to MbM-4 averaged an increase of 0.005 ft in elevation from March 2015 to March 2022. Comparison of the two set of values indicate that the downthrown side of the Egypt fault has

Over the last 7 years, the two monitoring points on the upthrown side of the Egypt Fault on Research Forest Drive both decreased 0.01 ft in elevation, whereas the two benchmarks on the downthrown side of the Egypt Fault both decreased 0.03 ft. From March 2015 to March 2022, the downthrown side has decreased approximately 0.02 ft relative to the upthrown side of the Egypt Fault. Over a 7-year period, the difference of 0.02 ft translates into an average subsidence rate of about 0.003 ft/year.

Figure 3 Satellite map showing the location of the Egypt Fault (Fugro, 2012), the W1A monitoring locations and calculated vertical displacement from March 2015 to March 2022 and the SJRA water line and pipe casing.

fault are less than 0.02 ft. Based on the information that INTERA has reviewed, INTERA concludes the water line is not at risk of damage from land subsidence where it crosses the Egypt Fault along Research Forest Drive for the next 50 years if land subsidence continues at its current rate and if the SJRA safeguards work as designed.

Along FM 2978, the 16-inch water line extends to SJRA Woodlands Division Plant No. 4. Instead of using pipe casing to protect the water line, a SJRA contractor installed a series of ball connections in the vicinity of Egypt Fault to accommodate movement of up to 0.25 inch of vertical movement per year over a 50-year period, or a total of 12.5 inches. Along a length of approximately 400 ft, six ball couplings were installed. After 7 years of monitoring, the changes in the monitoring benchmark elevations are less than 0.02 ft for both the upthrown and downthrown side of the fault. Based on the information that INTERA has reviewed, INTERA concludes that the water line is not at risk of damage from land subsidence where it crosses the Egypt Fault along FM 2978 for the next 50 years if land subsidence continues at its current rate and if the SJRA safeguards work as designed.

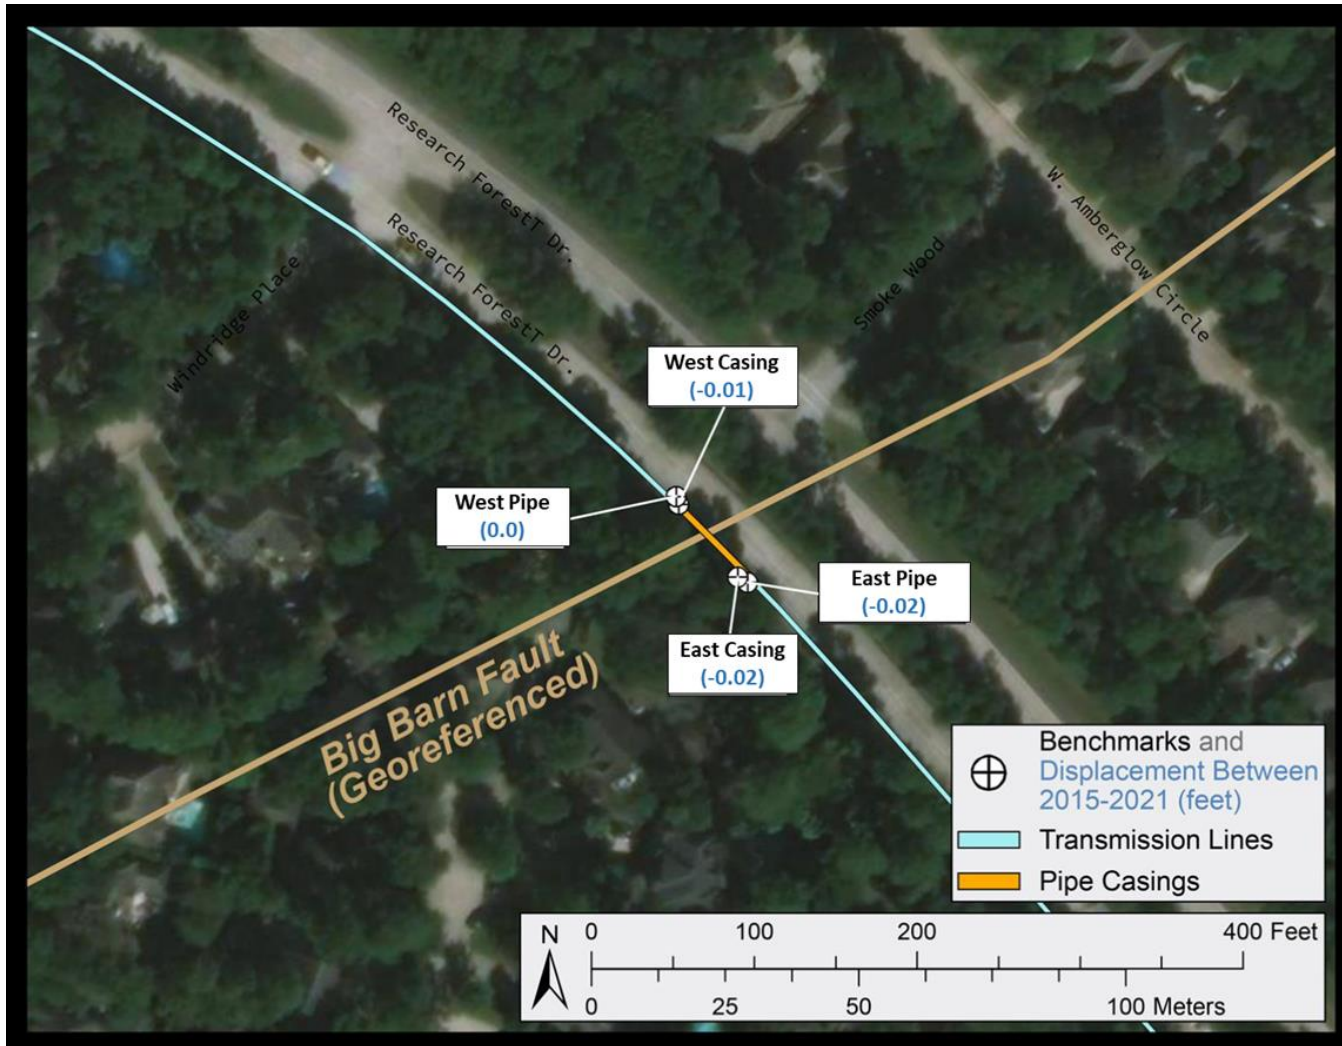
Along the W2A segment where four monitoring benchmarks on Research Forest Drive straddle the Big Barn Fault (Figure 4), the changes in the monitoring benchmark elevations suggest that greater land subsidence has occurred on the downthrown side than on the upthrown side of the Big Barn Fault. Based on the change in elevations of the four monitoring benchmarks over a seven-year period from March 2015 to March 2022, the land surface on downthrown side of the Big Barn Fault decreased 0.015 ft in elevation relative to the upthrown side of the Big Barn Fault. The 0.015 ft decrease in land elevation over a 7-year period translates into average subsidence rate of approximately 0.002 feet per year (ft/year).

Last 6 months: - Over the last 6 months, the four monitoring points along Research Forest Drive at the Big Barn Fault Monitoring System in Figure 4 had the following elevation changes:

- the two monitoring points on the upthrown side of the Big Barn Fault had 0.00 ft elevation change;
- the two monitoring points on the downthrown side of the Big Barn Fault had a decrease of 0.01 ft in elevation and had 0.00 ft elevation change and averaged a decrease of 0.005 ft change in elevation;

The changes in the elevation of monitoring points that straddle the Big Barn Fault indicate that the downthrown side of the fault has subsided approximately 0.015 ft more than the upthrown side of the fault. A 0.015 ft decrease in elevation translates into an average subsidence rate of approximately 0.002 ft/year.

Figure 4 Satellite map showing the location the Big Barn Fault (Fugro, 2012), the Big Barn Fault Monitoring System, calculated vertical displacement from March 2015 to March 2022, and the SJRA water line and pipe casing

INTERA has reviewed the drawings for the safeguard that SJRA has constructed for the transmission pipe at the Big Barn Fault Monitoring System. The safeguard is similar to the safeguard SJRA constructed using pipe casing for the Egypt Fault. The net change in the monitoring benchmark elevations at the Big Barn Fault over 7 years for both the upthrown and the downthrown side of the fault is 0.02 ft. The safeguards that were constructed are designed to handle 12.5 inches of vertical movement over 50 years. Based on the information that INTERA has reviewed, INTERA concludes that the water line is not at risk of damage from land subsidence where it crosses the Big Barn Fault along Research Forest Drive for the next 50 years if land subsidence continues at its current rate and if the SJRA safeguards work as designed.

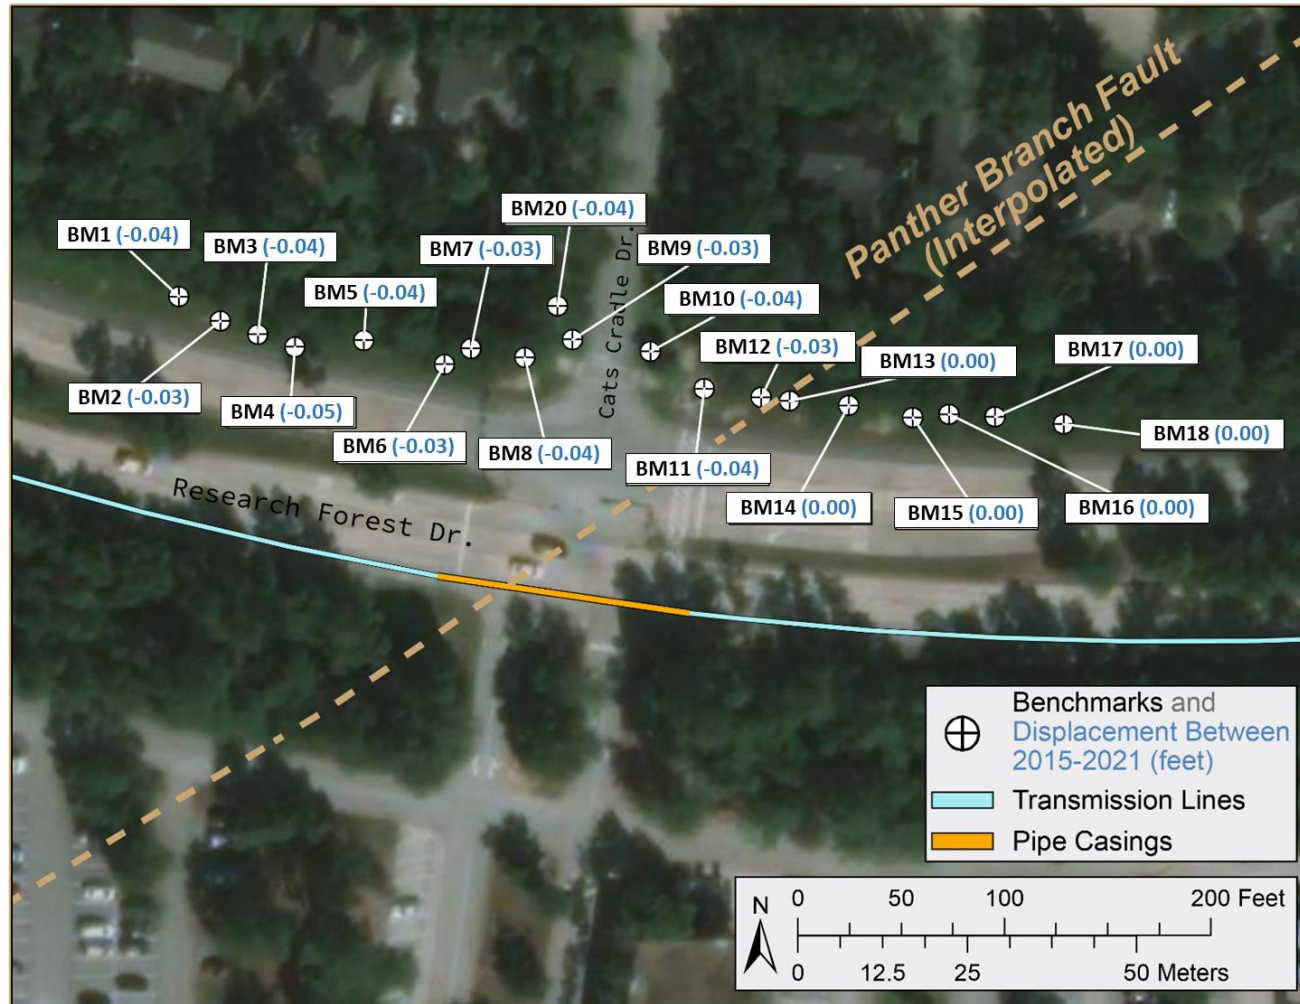
Along the W2A segment where 19 monitoring benchmarks on Research Forest Drive are located near the Panther Branch Fault (Figure 5), the changes in the monitoring benchmark elevations suggest that greater land subsidence has occurred on the downthrown side than on the upthrown side of the Panther Branch Fault. Based on the change in elevations of the 19 monitoring benchmarks over a seven-year period from March 2015 to March 2022, the land surface on downthrown side of the Panther Branch Fault decreased 0.037 ft in elevation relative to the upthrown side of the Panther Branch Fault. The 0.037 ft decrease in land elevation over a 7-year period translates into average subsidence rate of approximately 0.005 feet per year (ft/year).

Over the last 6 months the 19 monitoring benchmarks along Research Forest Drive at the Segment W2A Monitoring System in Figure 5 had the following elevation changes:

- the six monitoring benchmarks (MbM-13 through MbM-18) on the upthrown side of the Panther Branch Fault had elevation changes that ranged from 0.00 in elevation to an increase of 0.01 ft in elevation and averaged an increase of 0.004 ft in elevation;
- excluding monitoring benchmark MbM-10, the twelve monitoring benchmarks (MbM-1 through MbM-12 and MbM-20) on the downthrown side of the Panther Branch Fault had elevation changes that ranged from 0.00 ft in elevation to an increase of 0.02 ft in elevation. The twelve monitoring benchmarks averaged an increase of 0.004 ft in elevation. (The measured elevation at monitoring point MbM-10 was excluded because its measured elevation in September 2021 appears to be 0.03 ft too high based on analysis of all available data)

From September 2021 to March 2022, both the upthrown and the downthrown sides of the Panther Branch Fault along Research Forest Drive had an approximate increase 0.004 ft of elevation. Thus, the measured elevation did not indicate any land subsidence during the last six months. From September 2021 to March 2022, the downthrown side of the Big Barn Fault decreased approximately 0.005 ft more than the upthrown side of Big Barn Fault. However, given that the amount of change is less than the reported precision of the measured elevations, the 0.005 ft of elevation change should not be considered as an estimated amount of land subsidence that has occurred on the downside of the Panther Fault from September 2021 to March 2022.

From March 2015 to March 2022, the 19 monitoring benchmarks located along Research Forest Drive near the Panther Branch Fault in Figure 5 had the following elevation changes:

- the six monitoring benchmarks (MbM-13 through MbM-18) on the upthrown side of the Panther Branch Fault had elevation changes of 0.00 ft in elevation change and averaged 0.00 ft in elevation change;
- the thirteen monitoring benchmarks (MbM-1 through MbM-12 and MbM-20) on the downthrown side of the Panther Branch Fault had elevation changes that ranged from a decrease of 0.03 ft elevation to a decrease of 0.05 elevation and averaged a decrease of 0.037 ft in elevation.

The changes in the elevation of the monitoring benchmarks that are near the Panther Branch Fault indicate that the downthrown side of the fault has subsided approximately 0.037 ft more than the upthrown side of the fault. The 0.037 ft decrease in elevation translates into an average subsidence rate of approximately 0.005 ft/year.

Figure 5 Satellite map showing the location the Panther Branch Fault mapped by INTERA, the Segment W2A Monitoring System, calculated vertical displacement from March 2015 to March 2022, and the SJRA water line and pipe casing.

Because the Fugro report (2012) did not show that Panther Branch Fault crossing the water line, SJRA did not hire a contractor to construct safeguards to protect the water line from differential subsidence associated with the Panther Branch Fault. However, based on the location of the Panther Branch Fault mapped by INTERA in Figure 5, the Panther Branch Fault crosses a section of the water line that has been provided additional protection by being enclosed in pipe casing. Per discussion with SJRA, SJRA plans to continue to monitor any subsidence that is observed from the Segment W2A Monitoring System and discuss with water line experts if significant movement is observed.
