RE: Review of Fifteenth (15th) Re-measure of Elevations at Monitoring Benchmarks and Monitoring Points Along the Water Line Segments W1A and W2A in the Woodlands, Texas

Review of Fifteenth (15th) Re-measure of the Elevations at Monitoring Points and Monitoring Benchmarks along Water Line Segments W1A and W2A

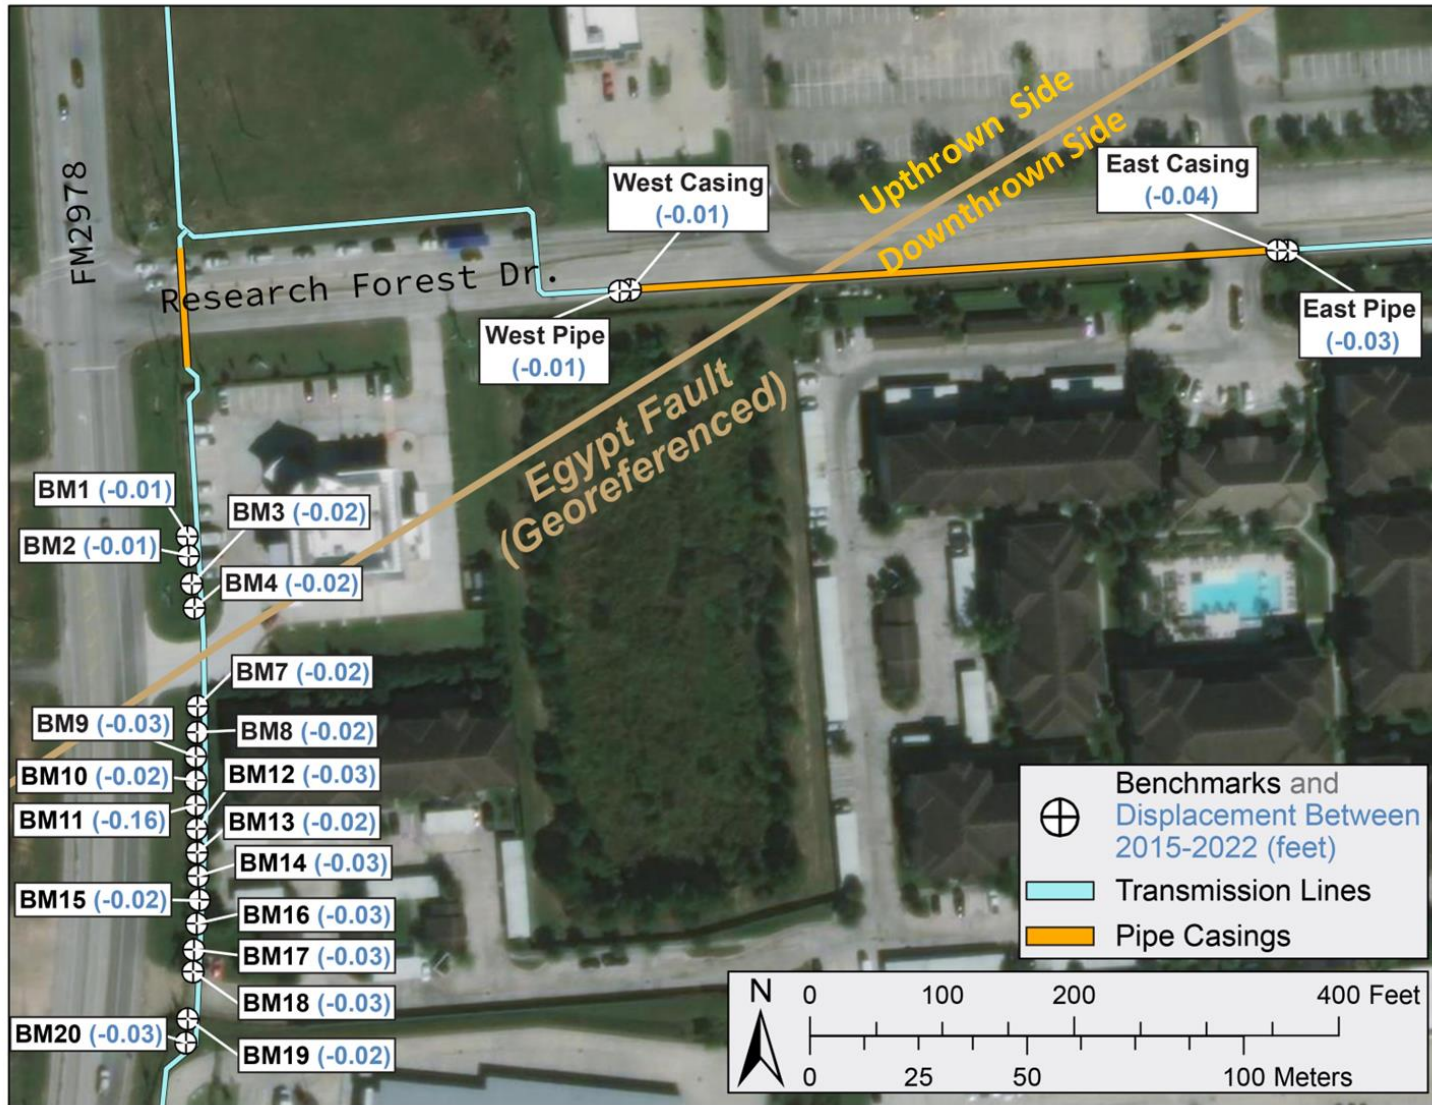
Figure 3 Satellite map showing the location of the Egypt Fault (Fugro, 2012), the W1A monitoring locations and calculated vertical displacement from March 2015 to March 2022 and the SJRA water line and pipe casing.

At the Egypt Fault Monitoring System (Figure 3), the changes in the elevations from March 2015 to September 2022 indicate that a greater decrease in pipe/casing elevation occurred on the downthrown side than on the upthrown side of the Egypt Fault. Over a 7.5-year period from 2015 to 2022, the pipe/casing elevation on the downthrown side of the Egypt Fault decreased 0.025 ft relative to the upthrown side of the Egypt Fault. The 0.025 ft decrease over a 7.5-year period translates into an average subsidence rate of approximately 0.003 ft/yr.

At the W1A segment where 18 monitoring benchmarks are located along FM 2978 (Figure 3), the changes in monitoring benchmark elevations from March 2015 to March 2022 indicate that a greater decrease in land elevation has occurred on the downthrown side than on the upthrown side of the Egypt Fault. Over the 7.5-year period from 2015 to 2022, the land surface on downthrown side of the Egypt Fault decreased 0.010 ft in elevation relative to the upthrown side of the Egypt Fault. The 0.010 decrease in land elevation over a 7.5-year period translates into average subsidence rate of approximately 0.001 ft/yr.

The differences in the elevation changes are viewed from two criteria. One criterion is whether there is a consistent set of data that supports a net downward movement on the downthrown side of the Egypt Fault. Neither set of measured elevation data indicates there is more land subsidence on the downthrown side than on the upthrown side of the Egypt Fault. The second criterion is how large are the changes in elevations between the upthrown and downthrown side of the fault compared to the reported accuracy of 0.01 ft for the elevation measurements. For both set of measured elevation data the observed average differences of less than 0.01 ft are too small compared to the 0.01 ft reported precision of the measured elevations to make definitive statements regarding the actual amount of vertical movement on the upthrown and downthrown side the Egypt Fault. Based on these two criteria, there is no conclusive evidence to indicate that the downthrown side of the Egypt Fault subsided from March 2022 to September 2022.

During the last 7.5 years, the monitoring data indicates that slightly more downward movement occurred on the downthrown side on the Egypt Fault. The difference is greatest along Research Forest Drive, where the downthrown side of the fault averages a decrease of about 0.025 ft in elevation than the upthrown side of the fault. This amount of elevation change indicates that the downthrown side of the Egypt Fault is subsiding at rate approximately 0.0033 ft/yr relative to the upthrown side of the Egypt Fault. Along FM 2978, the difference in the rate of subsidence is approximately 0.0013 ft/yr more for the downthrown side than the upthrown side of the Egypt Fault.

In the vicinity of the Egypt Fault Monitoring System along Research Forest Drive, SJRA's GRP 48-inch diameter water line is protected by a pipe casing along a 500-ft section that crosses over the Egypt Fault. The water line is constructed of steel and capable of shifting approximately 1-ft over the 500-ft interval. Because of the possibility that the water line could eventually have a differential movement of more than 1 ft, a pipe casing as a safeguard around the water line was constructed. The pipe casing safeguard is designed to protect the water line for up to 0.25 inches of vertical movement at the fault per year over a 50-year period. This amount of movement is equivalent to 12.5 inches over 50 years, which translates to an average rate of 0.021 ft/yr. The dip angle of the fault was estimated at 70 degrees. A 12.5-inch vertical movement is expected to cause the casing and pipe to bow and move horizontally up to 4 inches. The pipe and casing can deflect and "flex" with the vertical movement but a horizontal movement of 4 inches could stress the steel enough to break the joints. To protect against the horizontal movement, two expansion couplings, each of which can move up to 4 inches horizontally, were added at the pipe connections. These expansion joints allow up for 8 inches of horizontal movement. Several methods are in place to monitor the condition of the water line. One of these methods is measuring the change in elevations in the casing and pipe at the ends of the pipe casing. After 7.5 years of monitoring the change in the monitoring point elevations at the Egypt Fault Monitoring System, the downthrown side of the fault had subsided 0.025 ft relative to the upthrown side of the fault. Thus, the average rate of subsidence of the downthrown side of the fault relative to the upthrown side of the fault is approximately 0.003 ft/year. Based on the information that INTERA has reviewed, INTERA concludes the water line is not at risk of damage from land subsidence where it crosses the Egypt Fault along Research Forest Drive for the next 50 years if land subsidence continues at its current rate and if the SJRA safeguards work as designed.

Along FM 2978, the 16-inch water line extends to SJRA Woodlands Division Water Plant No. 4. Instead of using pipe casing to protect the water line, a SJRA contractor installed a series of ball connections in the vicinity of the Egypt Fault to accommodate movement of up to 0.25 inches of vertical movement per year over a 50-year period, or a total of 12.5 inches. Along a length of approximately 400 ft, six ball couplings were installed. After 7.5 years of monitoring, the changes in the monitoring benchmark elevations are 0.015 ft and 0.025 ft for the upthrown and downthrown side of the fault, respectively. Thus, the rate of subsidence of the downthrown side of the fault relative to the upthrown side of the fault is approximately 0.001 ft/yr. Based on the information that INTERA has reviewed, INTERA concludes that the water line is not at risk of damage from land subsidence where it crosses the Egypt Fault along FM 2978 for the next 50 years if land subsidence continues at its current rate and if the SJRA safeguards work as designed.

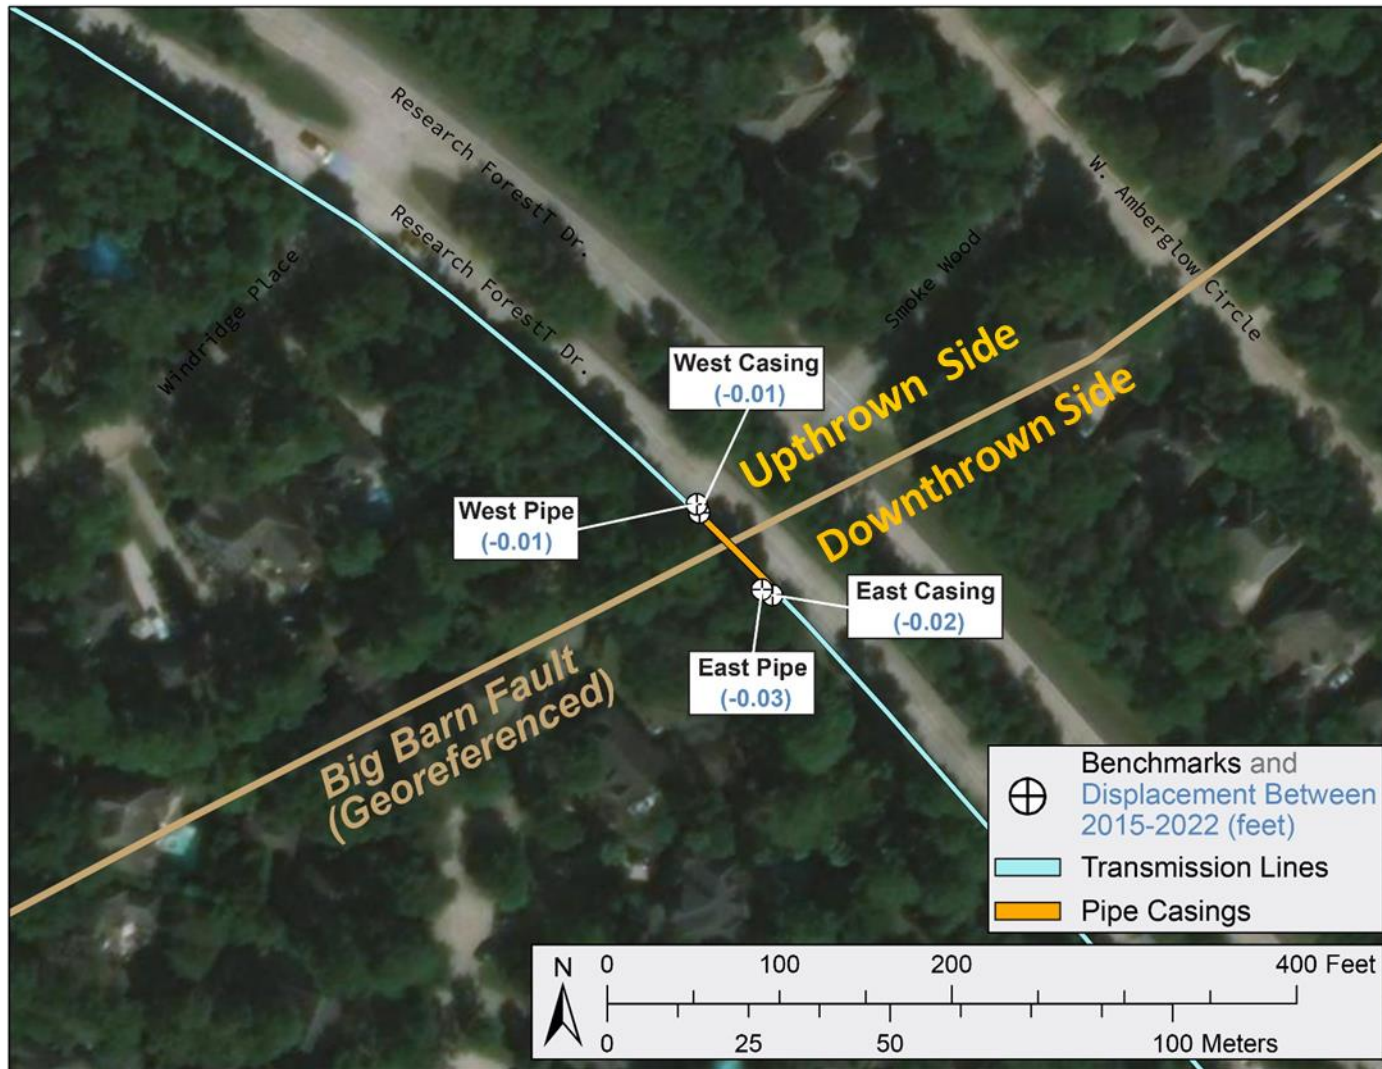
Figure 4 Satellite map showing the location the Big Barn Fault (Fugro, 2012), the Big Barn Fault Monitoring System, calculated vertical displacement from March 2015 to March 2022, and the SJRA water line and pipe casing

At the Big Barn Fault Monitoring System where four monitoring points on Research Forest Drive straddle the Big Barn Fault (Figure 4), the changes in the monitoring benchmark elevations indicate that a greater decrease in pipe/casing elevation has occurred on the downthrown side than on the upthrown side of the Big Barn Fault. Based on the change in elevations of the four monitoring benchmarks over a 7.5-year period from March 2015 to September 2022, the pipe/casing elevation on downthrown side of the Big Barn Fault decreased 0.015 ft relative to the upthrown side of the Big Barn Fault. The 0.015 ft decrease in pipe/casing over a 7.5-year period translates into average subsidence rate of approximately 0.002 ft/yr.

The changes in the elevation of monitoring points that straddle the Big Barn Fault indicate that the downthrown side of the fault has subsided approximately 0.015 ft more than the upthrown side of the fault. A 0.015 ft decrease in elevation translates into an average subsidence rate of approximately 0.002 ft/yr.

INTERA has reviewed the drawings for the safeguards that SJRA's contractor constructed for the transmission pipe at the Big Barn Fault Monitoring System. The safeguards are similar to the safeguards SJRA's contractor constructed using pipe casing for the Egypt Fault. The average change in the monitoring benchmark elevations at the Big Barn Fault over 7.5 years for the upthrown side and for the downthrown side of the Big Barn Fault are a decrease of 0.010 ft in elevation and a decrease of 0.025 ft in elevation, respectively. Thus, the decrease of downthrown side of the fault relative to the upthrown side is about 0.015 ft in 7.5 years, or approximately 0.002 ft/yr. The safeguards that were constructed are designed to handle 12.5 inches of vertical movement over 50 years or approximately 0.021 ft/year. Based on the information that INTERA has reviewed, INTERA concludes that the water line is not at risk of damage from land subsidence where it crosses the Big Barn Fault along Research Forest Drive for the next 50 years if land subsidence continues at its current rate and if the SJRA safeguards work as designed.

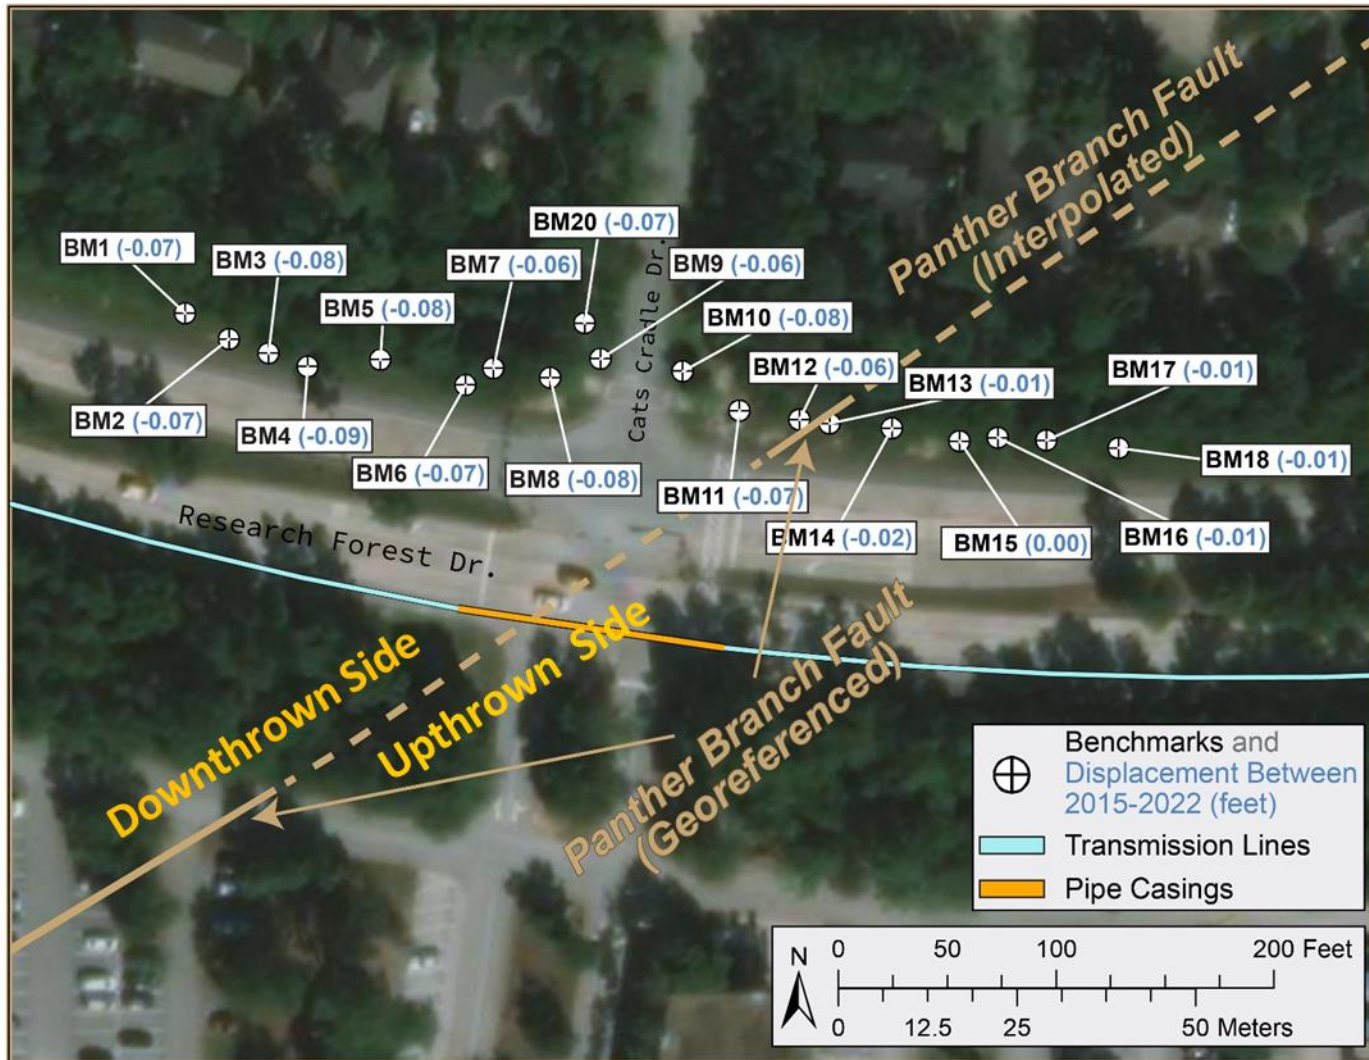
Figure 5 Satellite map showing the location the suspected Panther Branch Fault mapped by INTERA, the Segment W2A Monitoring System, calculated vertical displacement from March 2015 to March 2022, and the SJRA water line and pipe casing.

Along the W2A segment where 19 monitoring benchmarks on Research Forest Drive are located near the suspected Panther Branch Fault (Figure 5), the changes in the monitoring benchmark elevations suggest that greater land subsidence has occurred on the downthrown side than on the upthrown side of the suspected Panther Branch Fault. Based on the change in elevations of the 19 monitoring benchmarks over a 7.5-year period from March 2015 to September 2022, the land surface on downthrown side of the suspected Panther Branch Fault decreased 0.062 ft in elevation relative to the upthrown side of the suspected Panther Branch Fault. The 0.062 ft decrease in land elevation over a 7.5-year period translates into average subsidence rate of approximately 0.008 feet per year (ft /yr. However, the subsidence rate has increased over time during the 7.5-year and a significant rate increased occurred in 2022. Between March 2022 and September 2022, the downthrown side of the fault subsided at a rate of 0.051 ft/yr greater than the upthrown side of the fault.

From September 2022 to March 2022, the downthrown side of the suspected Panther Branch Fault along Research Forest Drive averaged about 0.025 ft of subsidence more than the upthrown side of the suspected Panther Branch Fault. The 0.025 ft difference is several times greater than the 0.01 ft reported accuracy of the measurement method and the measured elevation changes are very similar for adjacent benchmarks located on the downthrown and upthrown side of the fault. The evaluation of the data suggests a greater amount of subsidence has occurred in the last six months on the downthrown side of the fault

The changes in the elevation of the monitoring benchmarks that are near the suspected Panther Branch Fault indicate that the downthrown side of the fault has subsided approximately 0.062 ft more than the upthrown side of the fault. The 0.062 ft decrease in elevation translates into an average subsidence rate of approximately 0.008 ft/yr since March 2015.

with SJRA consultants who designed the water line. INTERA recommends SJRA continue with the suspected Panther Branch Fault study to determine if and where the suspected Panther Branch Fault crosses the SJRA GRP water line and any associated mitigation measures recommended.

Because the Fugro report (2012) did not show that the suspected Panther Branch Fault crossing the water line, SJRA's consultant did not design nor did SJRA's contractor construct safeguards to protect the water line from differential subsidence associated with the suspected Panther Branch Fault. Per discussion with SJRA, SJRA plans to continue to monitor subsidence using the benchmarks associated with the Segment W2A Monitoring System. SJRA has also commissioned a consultant to study the suspected Panther Branch Fault to determine if the fault crosses the water line and what safeguards may be needed.

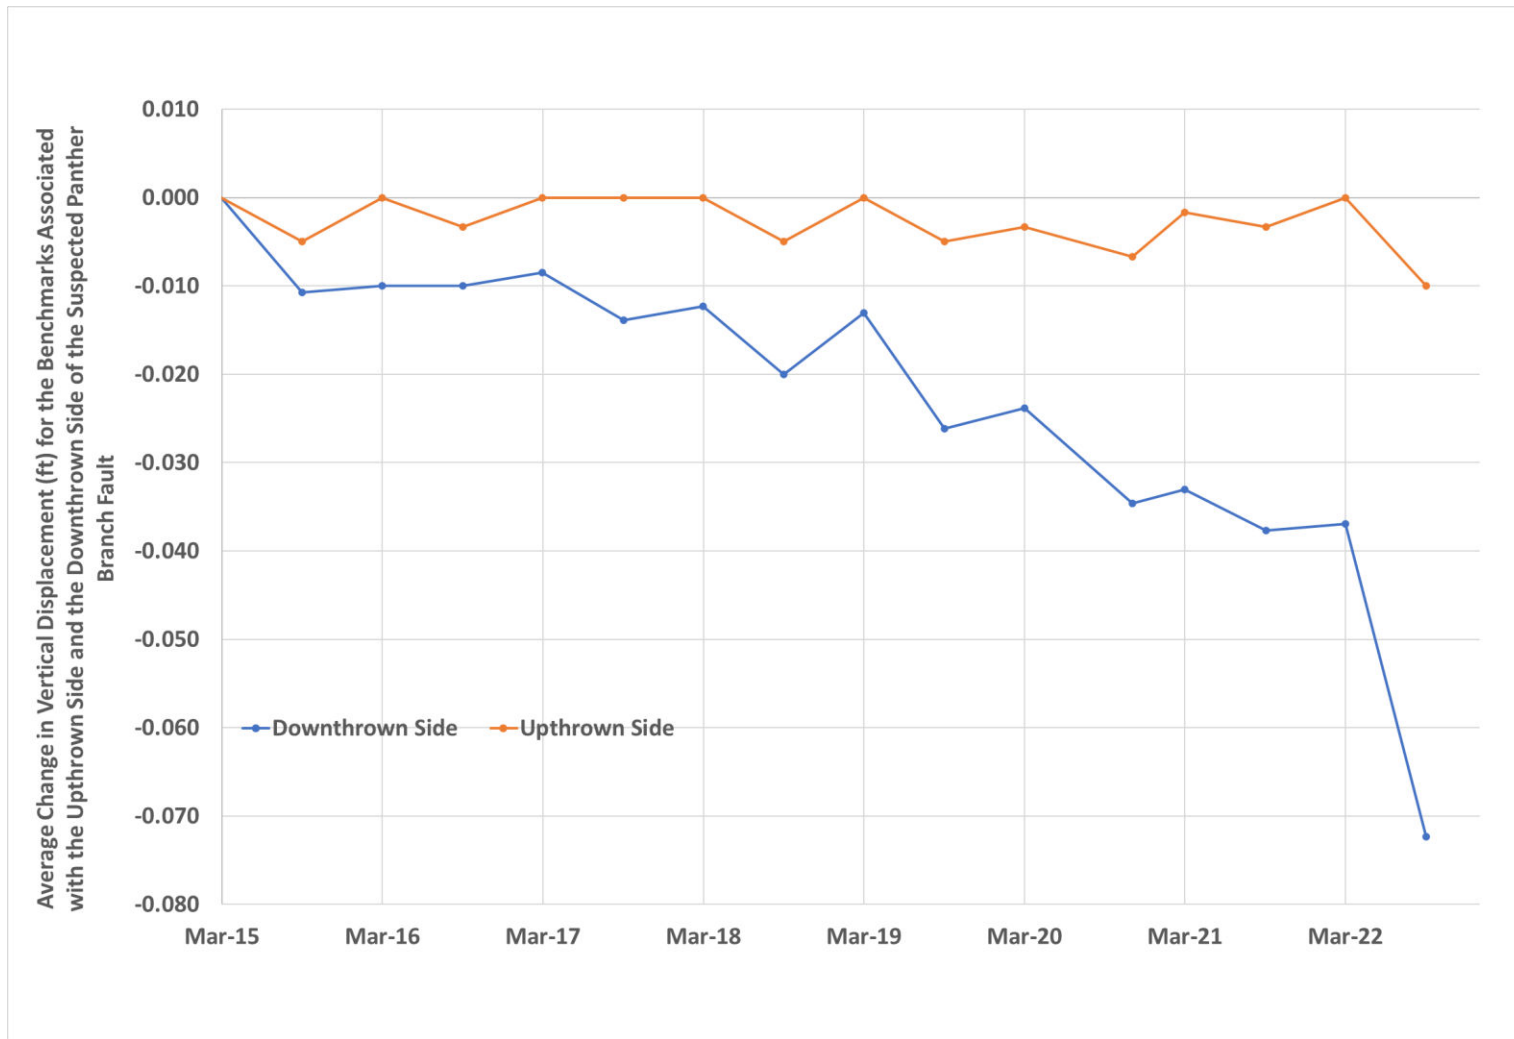
Figure 6 Comparison of average vertical displacement for the benchmarks located on the upthrown side and the downthrown side of the suspected Panther Branch Fault associated with the Segment W2A Monitoring System.

Figure 6 shows graphs for the average vertical displacement calculated for the benchmarks located on the upthrown side and the downthrown side of the suspected Panther Branch Fault as a function of time since March 2015. The graphs show that downthrown side of the fault has consistently greater decrease in elevation than does the upthrown side. Whereas the upthrown side of the fault has not subsided more than 0.01 ft at any time within the 7.5-year monitoring period, the downthrown side of the fault has exhibited a clear trend of declining elevation with higher displacement rates at later times.

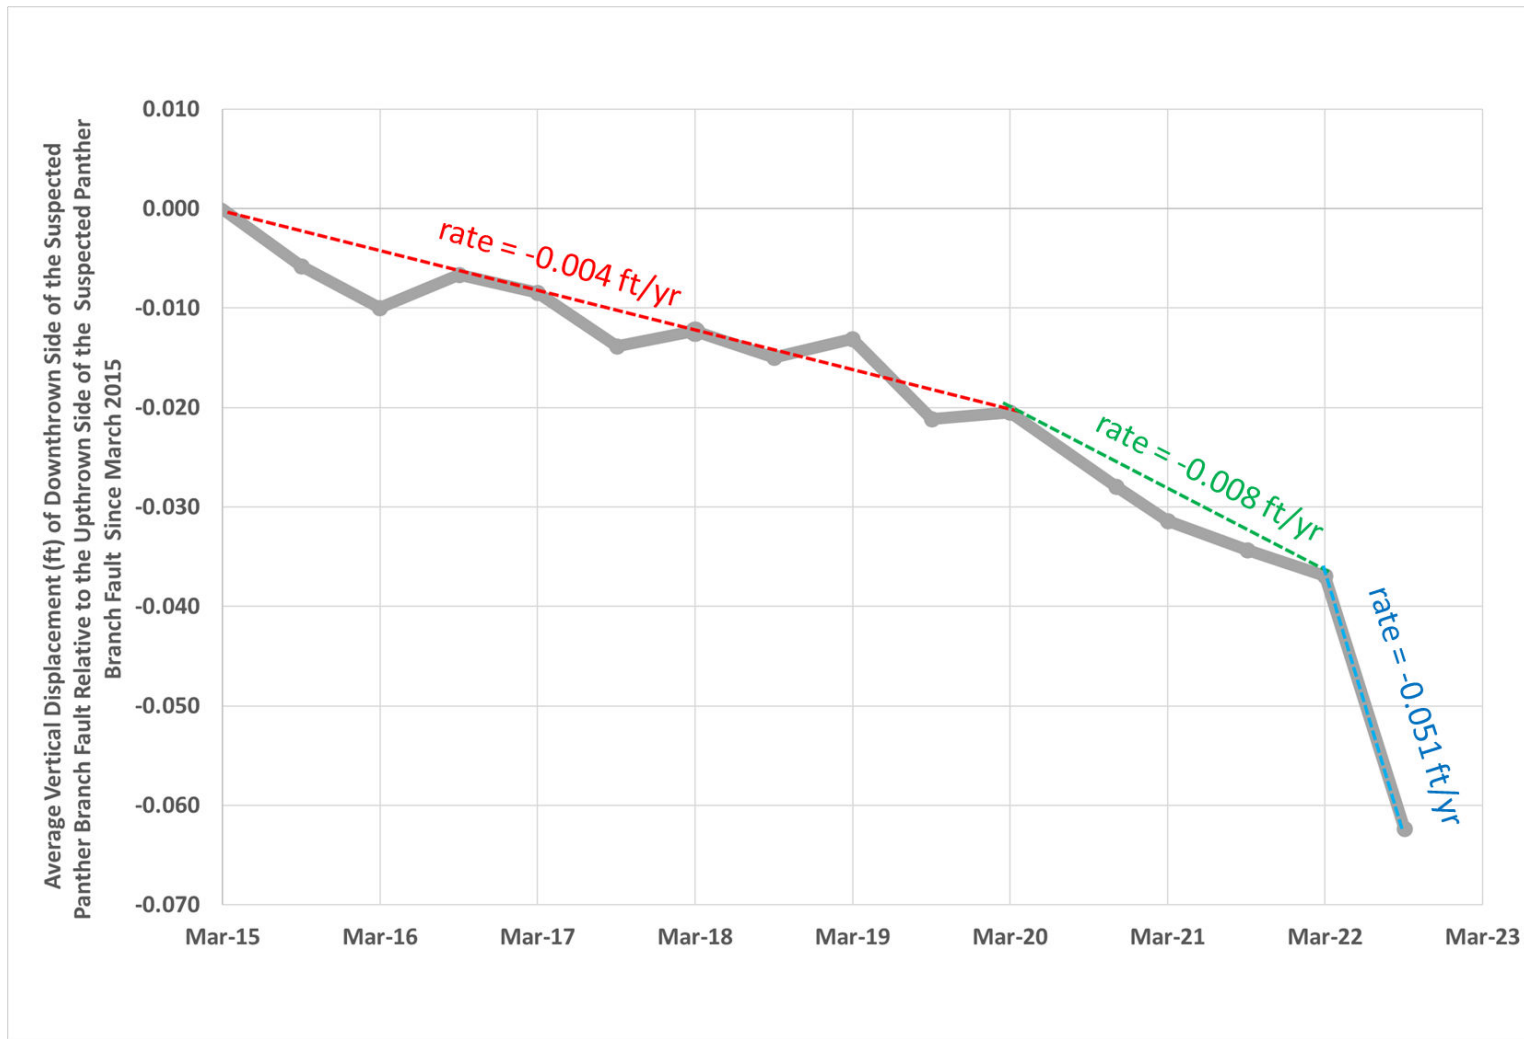
Figure 7 Relative vertical displacement and rates for relative vertical displacement for the downthrown side of the suspected Panther Branch Fault based on benchmarks associated with the Segment W2A Monitoring System

Figure 7 and **Table 5** show the rates of vertical displacement for the downthrown side of suspected Panther Branch Fault relative to the upthrown side of the suspected Panther Branch Fault. The relative rate is calculated by subtracting the rate of displacement of the upthrown side from the rate of displacement of the downthrown side. A potentially important observation is that the relative vertical displacements are increasing in magnitude over time and that a rate increase occurred between March 2022 and September 2022.
