RE: Review of Sixteenth(16th) Re-measure of Elevations at Monitoring Benchmarks and Monitoring Points Along the Water Line Segments W1A and W2A in the Woodlands, Texas

Review of Sixteenth (16th) Re-measure of the Elevations at Monitoring Points and Monitoring Benchmarks along Water Line Segments W1A and W2A

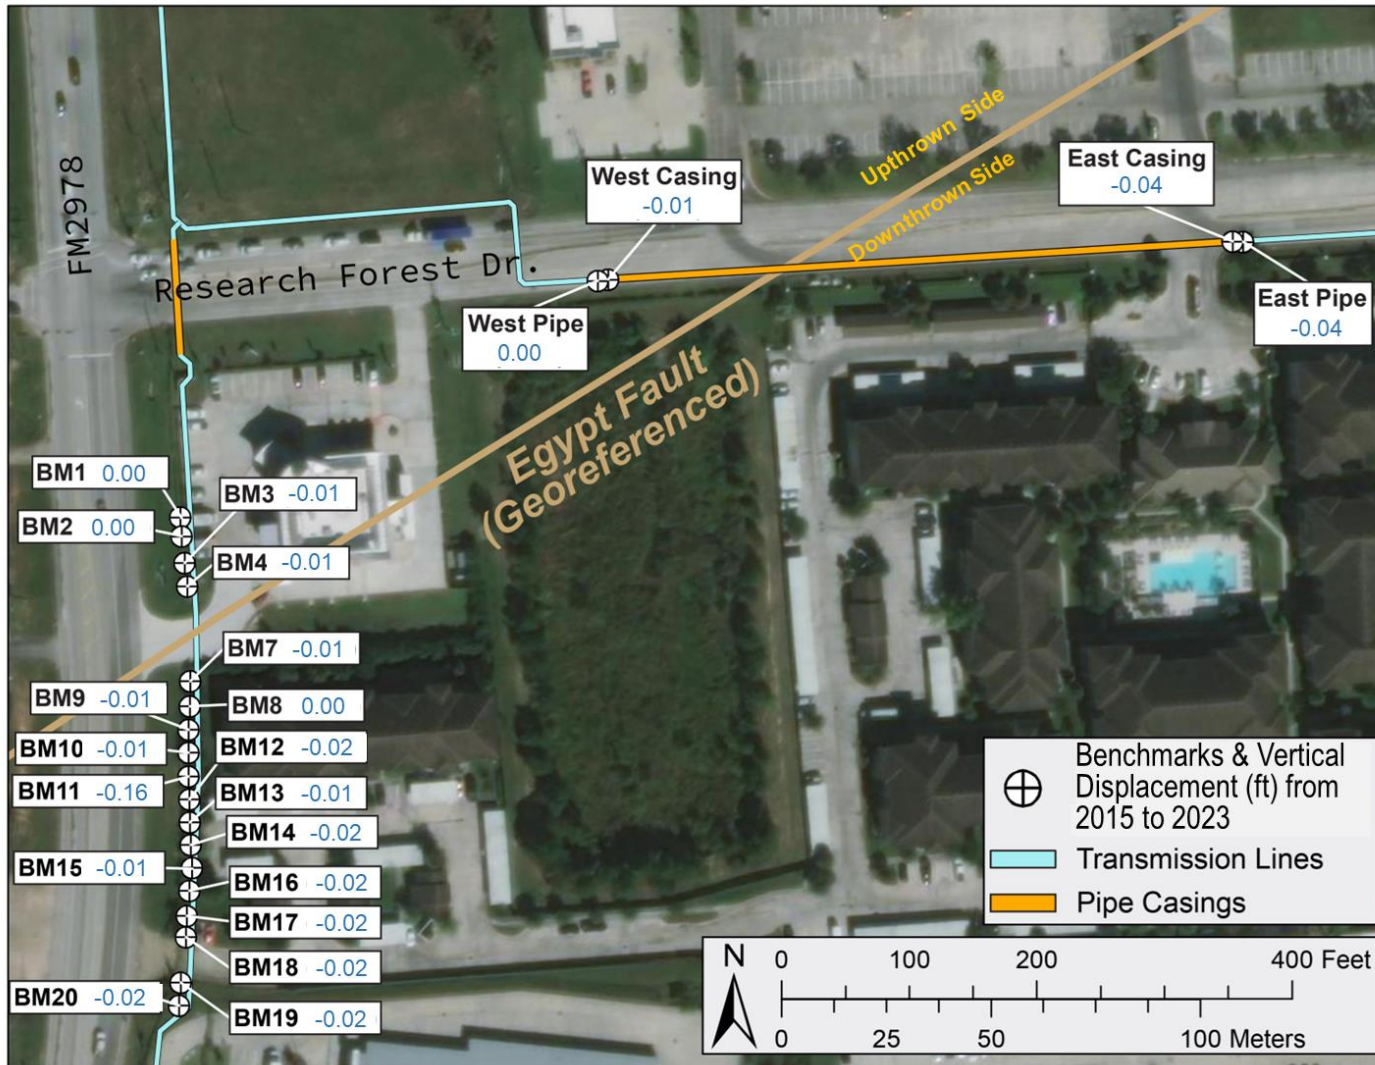
Figure 3 Satellite map showing the location of the Egypt Fault (Fugro, 2012), the W1A monitoring locations and calculated vertical displacement from March 2015 to March 2022 and the SJRA water line and pipe casing.

At the Egypt Fault Monitoring System (Figure 3), the changes in the elevations from March 2015 to March 2023 indicate that a greater decrease in pipe/casing elevation occurred on the downthrown side than on the upthrown side of the Egypt Fault. Over a 8-year period from 2015 to 2023, the pipe/casing elevation on the downthrown side of the Egypt Fault decreased 0.035 ft relative to the upthrown side of the Egypt Fault. The 0.035 ft decrease over a 8-year period translates into an average subsidence rate of approximately 0.0044 ft/yr.

At the W1A segment where 18 monitoring benchmarks are located along FM 2978 (Figure 3), the changes in monitoring benchmark elevations from March 2015 to March 2023 indicate that a greater decrease in land elevation has occurred on the downthrown side than on the upthrown side of the Egypt Fault. Over the 8-year period from 2015 to 2023, the land surface on downthrown side of the Egypt Fault decreased 0.010 ft in elevation relative to the upthrown side of the Egypt Fault. The 0.010 decrease in land elevation over a 8-year period translates into average subsidence rate of approximately 0.0012 ft/yr. (note: as explained below benchmark 11 was not included in the analysis)

During the last 8 years, the monitoring data indicates that slightly more downward movement occurred on the downthrown side on the Egypt Fault. The difference is greatest along Research Forest Drive, where the downthrown side of the fault averaged a decrease of about 0.035 ft in elevation more than the upthrown side of the fault. This amount of elevation change indicates that the downthrown side of the Egypt Fault is subsiding at rate approximately 0.0044 ft/yr relative to the upthrown side of the Egypt Fault. Along FM 2978, the difference in the rate of subsidence is approximately 0.0012 ft/yr more for the downthrown side than the upthrown side of the Egypt Fault.

In the vicinity of the Egypt Fault Monitoring System along Research Forest Drive, SJRA's GRP 48-inch diameter water line is protected by a pipe casing along a 500-ft section that crosses over the Egypt Fault. The water line is constructed of steel and capable of shifting approximately 1-ft over the 500-ft interval. Because of the possibility that the water line could eventually have a differential movement of more than 1 ft, a pipe casing as a safeguard around the water line was constructed. The pipe casing safeguard is designed to protect the water line for up to 0.25 inches of vertical movement at the fault per year over a 50-year period. This amount of movement is equivalent to 12.5 inches over 50 years, which translates to an average rate of 0.021 ft/yr. The dip angle of the fault was estimated at 70 degrees. A 12.5-inch vertical movement is expected to cause the casing and pipe to bow and move horizontally up to 4 inches. The pipe and casing can deflect and "flex" with the vertical movement but a horizontal movement of 4 inches could stress the steel enough to break the joints. To protect against the horizontal movement, two expansion couplings, each of which can move up to 4 inches horizontally, were added at the pipe connections. These expansion joints allow up for 8 inches of horizontal movement. Several methods are in place to monitor the condition of the water line. One of these methods is measuring the change in elevations in the casing and pipe at the ends of the pipe casing. After 8 years of monitoring the change in the monitoring point elevations at the Egypt Fault Monitoring System, the downthrown side of the fault had subsided 0.035 ft relative to the upthrown side of the fault. Thus, the average rate of subsidence of the downthrown side of the fault relative to the upthrown side of the fault is approximately 0.0044 ft/year. Based on the information that INTERA has reviewed, INTERA concludes the water line is not at risk of damage from land subsidence where it crosses the Egypt Fault along Research Forest Drive for the next 50 years if land subsidence continues at its current rate and if the SJRA safeguards work as designed.

Along FM 2978, the 16-inch water line extends to SJRA Woodlands Division Water Plant No. 4. Instead of using pipe casing to protect the water line, a SJRA contractor installed a series of ball connections in the vicinity of the Egypt Fault to accommodate movement of up to 0.25 inches of vertical movement per year over a 50-year period, or a total of 12.5 inches. Along a length of approximately 400 ft, six ball couplings were installed. During the 8 years of monitoring, the average changes in the monitoring benchmark elevations are a decrease of 0.005 ft and a decrease of 0.015 ft on the upthrown and downthrown side of the fault, respectively. Thus, the subsidence of the downthrown side of the fault relative to the upthrown side of the fault is approximately 0.010 over 8 years, which translates to 0.0012 ft/yr. Based on the information that INTERA has reviewed, INTERA concludes that the water line is not at risk of damage from land subsidence where it crosses the Egypt Fault along FM 2978 for the next 50 years if land subsidence continues at its current rate and if the SJRA safeguards work as designed.

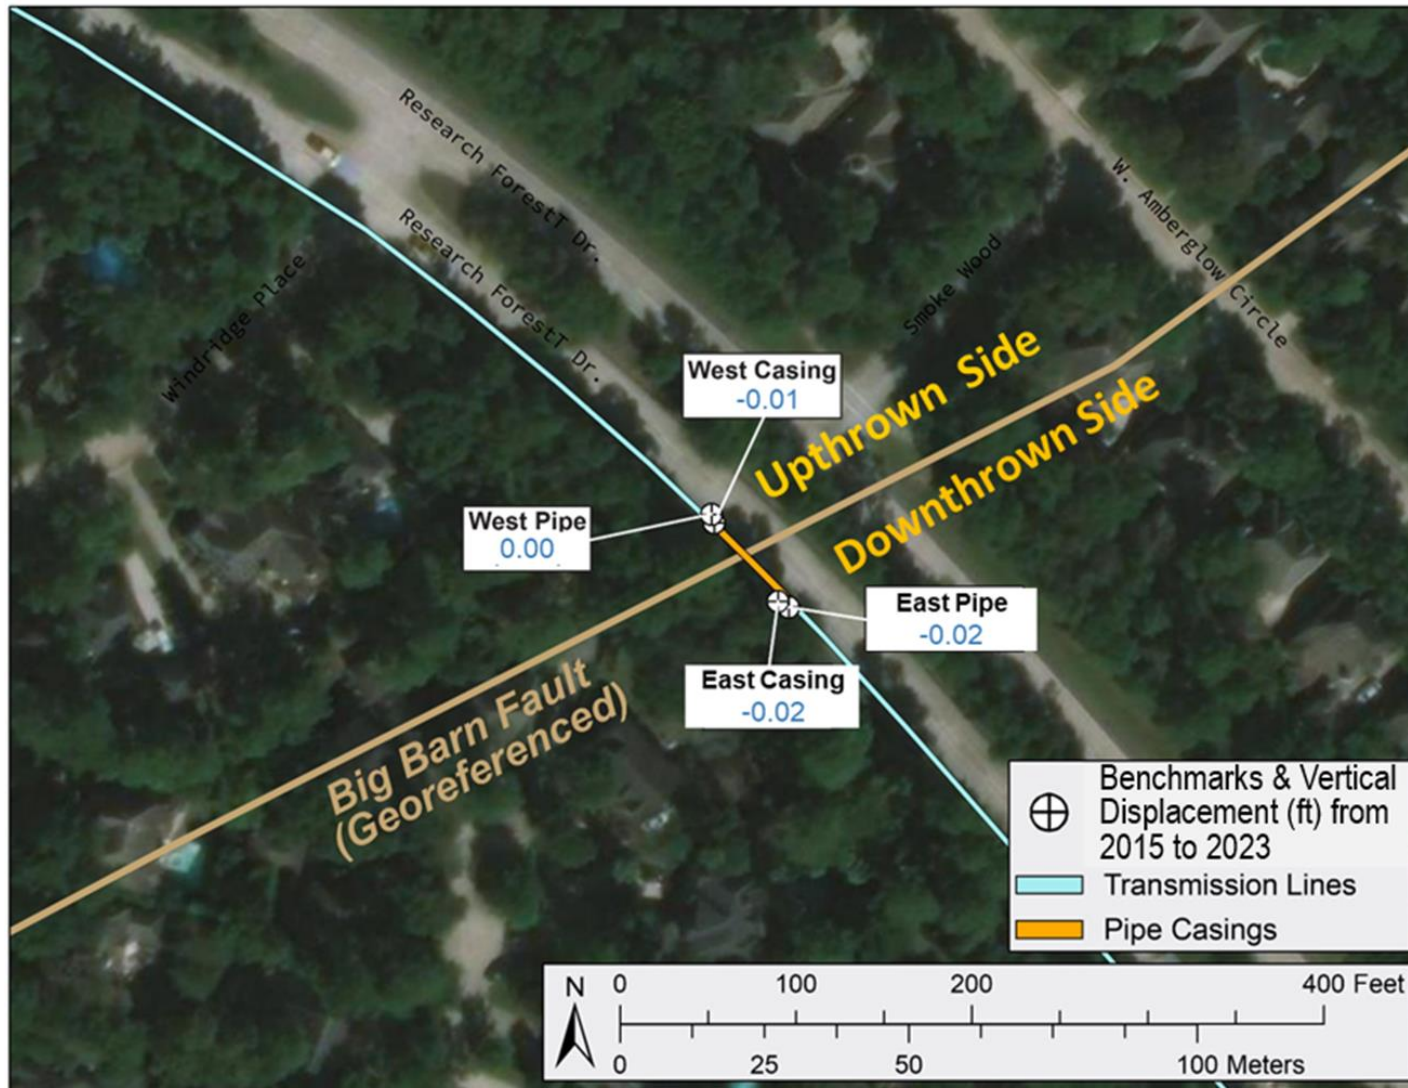
Figure 4 Satellite map showing the location the Big Barn Fault (Fugro, 2012), the Big Barn Fault Monitoring System, calculated vertical displacement from March 2015 to March 2022, and the SJRA water line and pipe casing

At the Big Barn Fault Monitoring System where four monitoring points on Research Forest Drive straddle the Big Barn Fault (Figure 4), the changes in the monitoring benchmark elevations indicate that a greater decrease in pipe/casing elevation has occurred on the downthrown side than on the upthrown side of the Big Barn Fault. Based on the change in elevations of the four monitoring benchmarks over a 8-year period from March 2015 to March 2023, the pipe/casing elevation on downthrown side of the Big Barn Fault decreased 0.015 ft relative to the upthrown side of the Big Barn Fault. The 0.015 ft decrease in pipe/casing over a 8-year period translates into average subsidence rate of approximately 0.0019 ft/yr.

The changes in the elevation of monitoring points that straddle the Big Barn Fault indicate that the downthrown side of the fault has subsided approximately 0.015 ft more than the upthrown side of the fault. A 0.015 ft decrease in elevation translates into an average subsidence rate of approximately 0.002 ft/yr.

INTERA has reviewed the drawings for the safeguards that SJRA's contractor constructed for the transmission pipe at the Big Barn Fault Monitoring System. The safeguards are similar to the safeguards SJRA's contractor constructed using pipe casing for the Egypt Fault. The average change in the monitoring benchmark elevations at the Big Barn Fault over 8 years for the upthrown side and for the downthrown side of the Big Barn Fault are a decrease of 0.005 ft in elevation and a decrease of 0.020 ft in elevation, respectively. Thus, the decrease of the downthrown side of the fault relative to the upthrown side is about 0.015 ft in 8 years, or approximately 0.002 ft/yr. The safeguards that were constructed are designed to handle 12.5 inches of vertical movement over 50 years or approximately 0.021 ft/year. Based on the information that INTERA has reviewed, INTERA concludes that the water line is not at risk of damage from land subsidence where it crosses the Big Barn Fault along Research Forest Drive for the next 50 years if land subsidence continues at its current rate and if the SJRA safeguards work as designed.

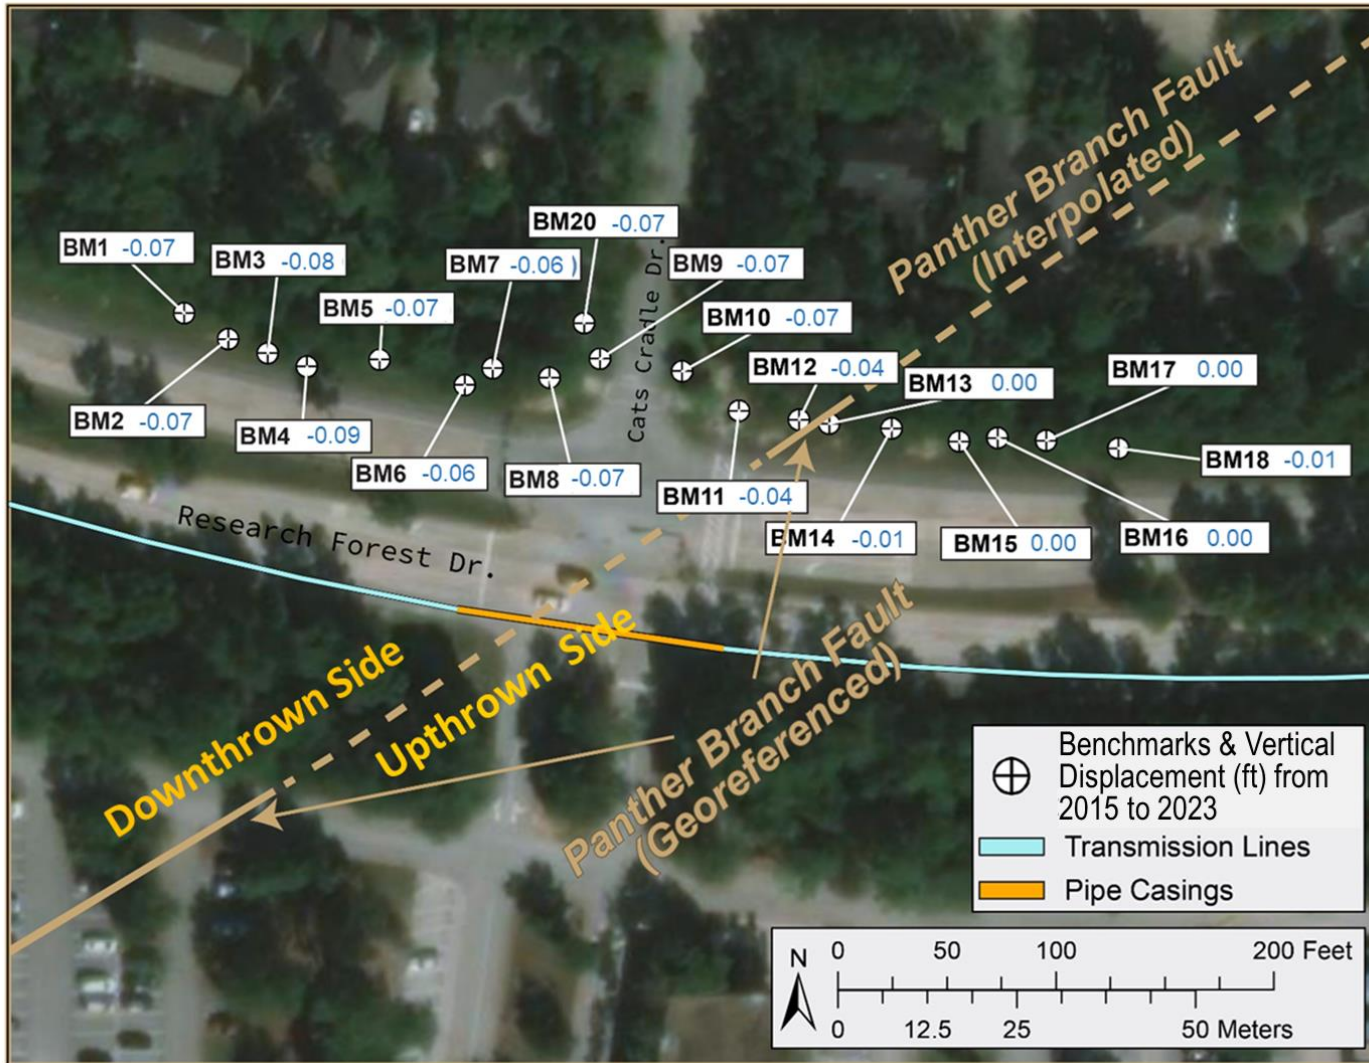
Figure 5 Satellite map showing the location the suspected Panther Branch Fault mapped by INTERA, the Segment W2A Monitoring System, calculated vertical displacement from March 2015 to March 2022, and the SJRA water line and pipe casing.

Along the W2A segment where 19 monitoring benchmarks on Research Forest Drive are located near the suspected Panther Branch Fault (Figure 5), the changes in the monitoring benchmark elevations suggest that greater land subsidence has occurred on the downthrown side than on the upthrown side of the suspected Panther Branch Fault. Based on the change in elevations of the 19 monitoring benchmarks over a 8-year period from March 2015 to March 2023, the land surface on downthrown side of the suspected Panther Branch Fault decreased 0.063 ft in elevation relative to the upthrown side of the suspected Panther Branch Fault. The 0.063 ft decrease in land elevation over a 8-year period translates into average subsidence rate of approximately 0.0079 feet per year (ft /yr).

The changes in the elevation for the monitoring benchmarks near the suspected Panther Branch Fault indicate that the downthrown side of the fault has subsided approximately 0.063 ft more than the upthrown side of the fault. The 0.063 ft decrease in elevation translates into an average subsidence rate of approximately 0.008 ft/yr since March 2015.

Because the Fugro report (2012) did not show that the suspected Panther Branch Fault crossing the water line, SJRA's consultant did not design nor did SJRA's contractor construct safeguards to protect the water line from differential subsidence associated with the suspected Panther Branch Fault. Per discussion with SJRA, SJRA plans to continue to monitor subsidence using the benchmarks associated with the Segment W2A Monitoring System. SJRA has also commissioned a consultant to study-the suspected Panther Branch Fault to determine if the fault crosses the water line and if so, what safeguards may be needed.

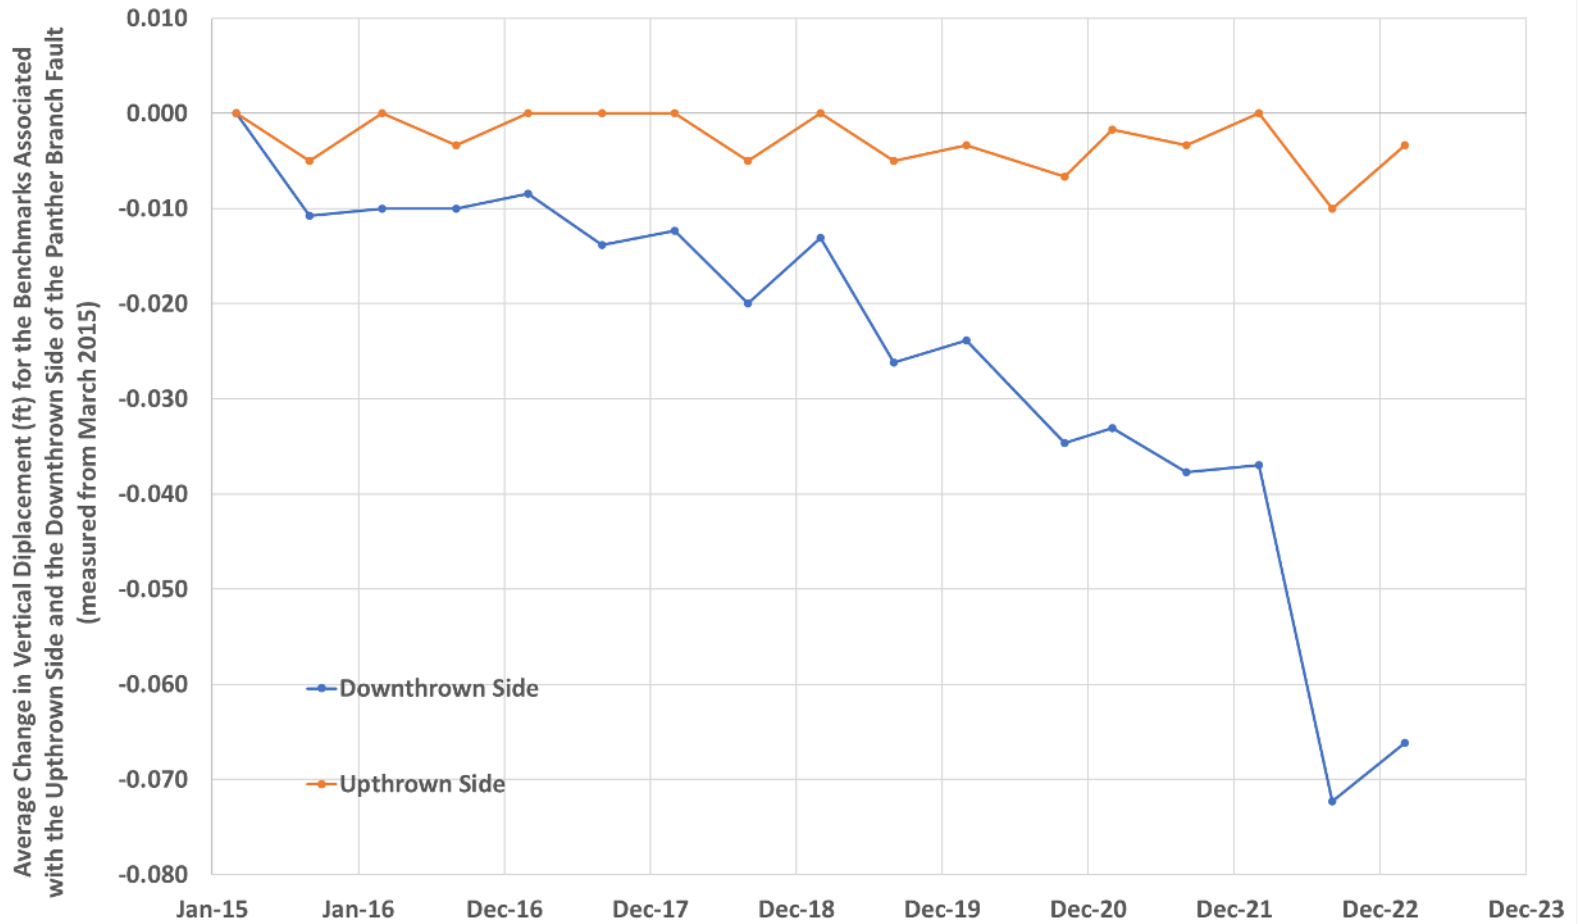
Figure 6 Comparison of average vertical displacement for the benchmarks located on the upthrown side and the downthrown side of the suspected Panther Branch Fault associated with the Segment W2A Monitoring System.

Figure 6 shows graphs for the average vertical displacement calculated for the benchmarks located on the upthrown side and the downthrown side of the suspected Panther Branch Fault as a function of time since March 2015. The graphs show that downthrown side of the fault has consistently greater decrease in elevation than does the upthrown side. Whereas the upthrown side of the fault has not subsided more than 0.01 ft at any time within the 8 year monitoring period, the downthrown side of the fault has exhibited a general trend of declining elevation with greater displacement rates at later times even with a slight rebound occurring from September 2022 to March 2023.

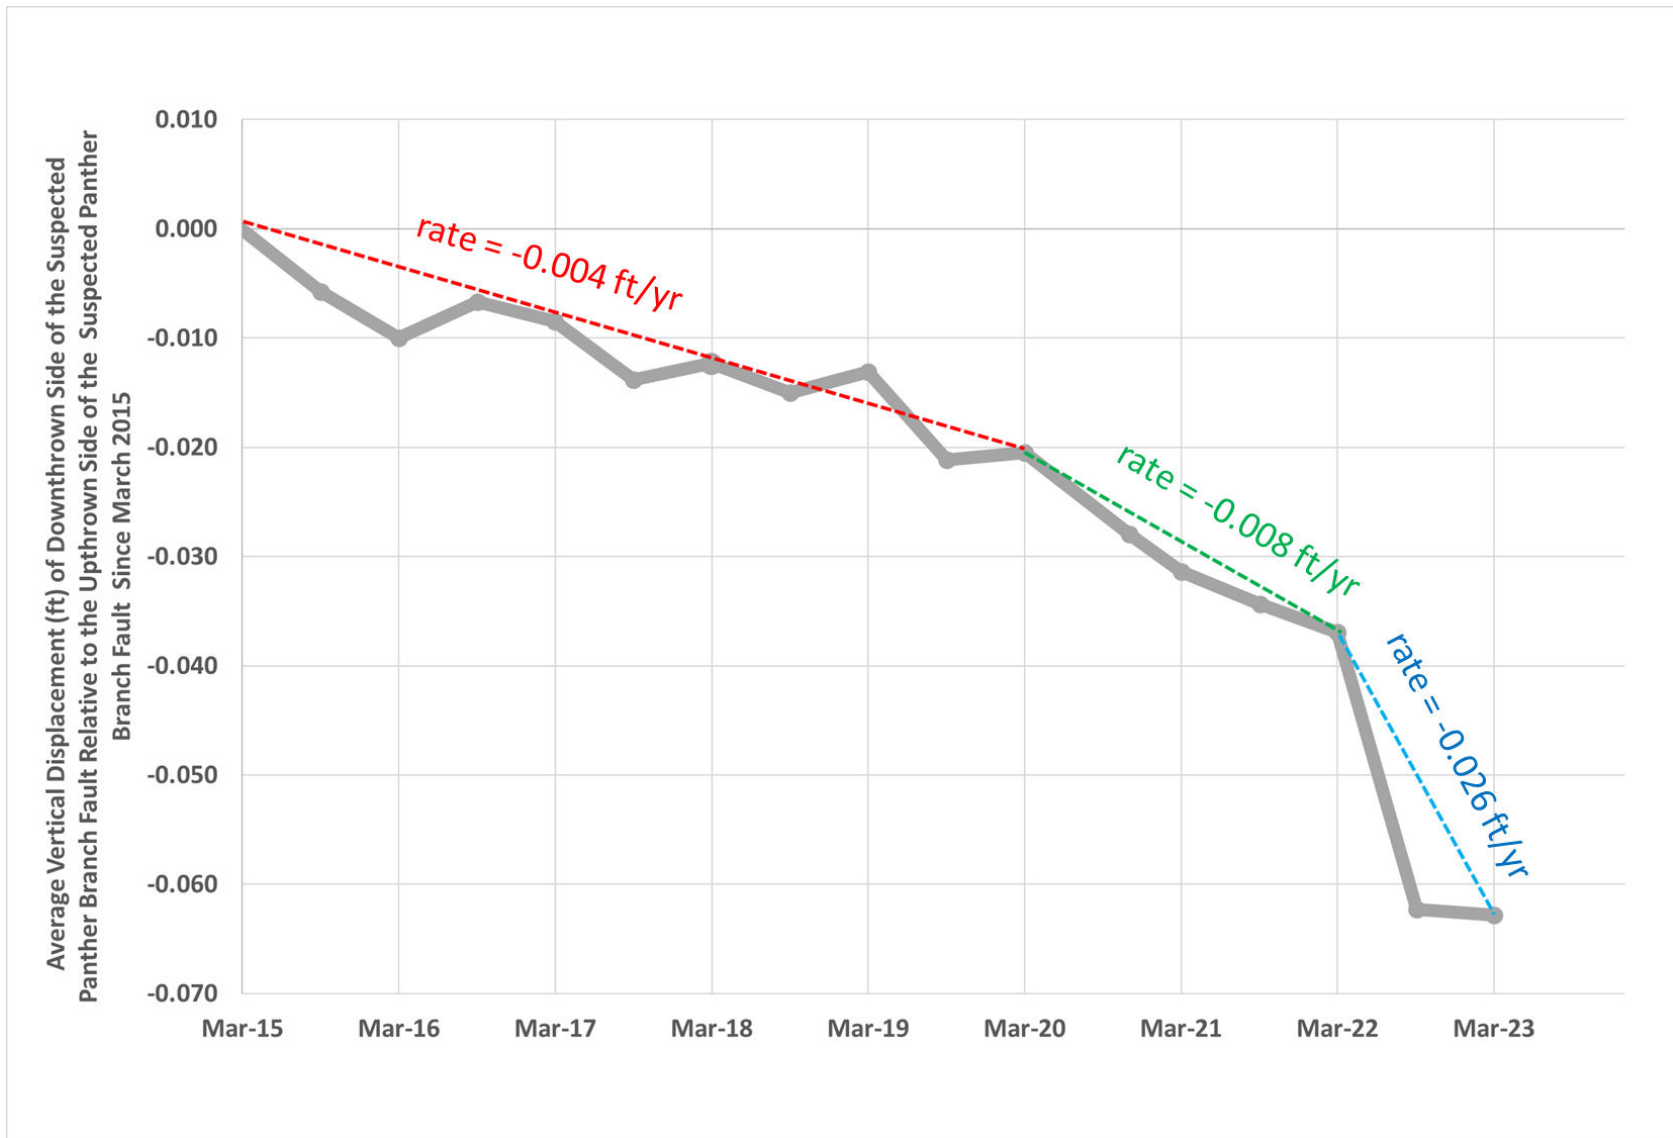
Figure 7 Relative vertical displacement and rates for relative vertical displacement for the downthrown side of the suspected Panther Branch Fault based on benchmarks associated with the Segment W2A Monitoring System

Figure 7 and **Table 5** show the rates of vertical displacement for the downthrown side of suspected Panther Branch Fault relative to the upthrown side of the suspected Panther Branch Fault. The relative rate is calculated by subtracting the rate of displacement of the upthrown side from the rate of displacement of the downthrown side. The temporal changes in the displacement can be characterized into three periods: 1) from March 2015 to March 2020, the vertical displacement averaged 0.004 ft downward; 2) from March 2020 to March 2022, the vertical displacement averaged 0.008 ft/yr downward; and, 3) from March 2022 to March 2023, the vertical displacement averaged 0.026 ft/yr downward.
