**RE: Review of Seventeenth (17th) Re-measure of Elevations at Monitoring Benchmarks and Monitoring Points Along the Water Line Segments W1A and W2A in the Woodlands, Texas**

### Review of Seventeenth (17th) Re-measure of the Elevations at Monitoring Points and Monitoring Benchmarks along Water Line Segments W1A and W2A

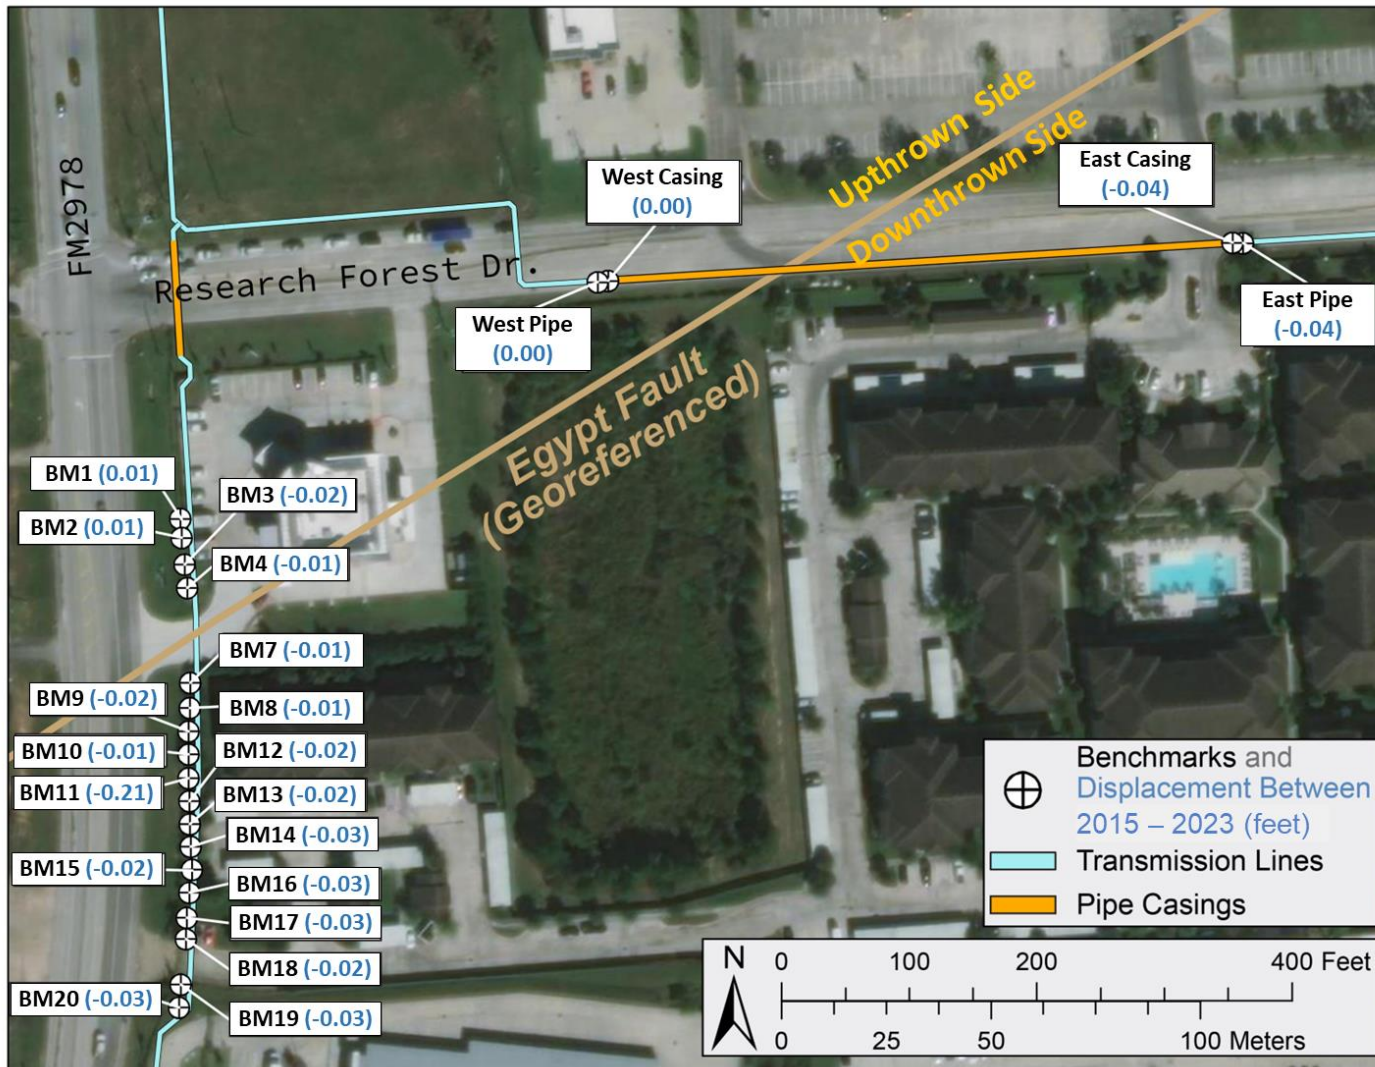
Egypt Fault Monitoring System - At the Egypt Fault Monitoring System (Figure 3), the changes in the elevations from March 2015 to September 2023 indicate that a greater decrease in pipe/casing elevation occurred on the downthrown side than on the upthrown side of the Egypt Fault. Over an 8.5-year period from 2015 to 2023, the pipe/casing elevation on the downthrown side of the Egypt Fault decreased 0.04 ft relative to the upthrown side of the Egypt Fault. The 0.04 ft decrease over an 8.5-year period translates into an average subsidence rate of approximately 0.0047 ft/yr.

W1A Segment - At the W1A segment where 18 monitoring benchmarks are located along FM 2978 (Figure 3), the changes in monitoring benchmark elevations from March 2015 to September 2023 indicate that a greater decrease in land elevation has occurred on the downthrown side than on the upthrown side of the Egypt Fault. Over the 8.5-year period from 2015 to 2023, the land surface on downthrown side of the Egypt Fault decreased 0.019 ft in elevation relative to the upthrown side of the Egypt Fault. The 0.019 ft decrease in land elevation over an 8.5-year period translates into an average subsidence rate of approximately 0.0022 ft/yr. (note: as explained below benchmark 11 was not included in the analysis).

During the last 8.5 years, the monitoring data indicates that more downward movement occurred on the downthrown side on the Egypt Fault. Along Research Forest Drive, the downthrown side of the fault averaged a decrease 0.04 ft in elevation more than the upthrown side of the fault. This amount of elevation change indicates that the downthrown side of the Egypt Fault is subsiding at rate approximately 0.0047ft/yr relative to the upthrown side of the Egypt Fault. Along FM 2978, the downthrown side of the fault averaged a decrease 0.009 ft in elevation more than the upthrown side of the fault. These amounts of elevation change are too small to be consider conclusive evidence that land subsidence is occurring along Egypt Fault where it intersects FM 2978.

Figure 3 Satellite map showing the location of the Egypt Fault (Fugro, 2012), the W1A monitoring locations and calculated vertical displacement from March 2015 to September 2023 and the SJRA water line and pipe casing.

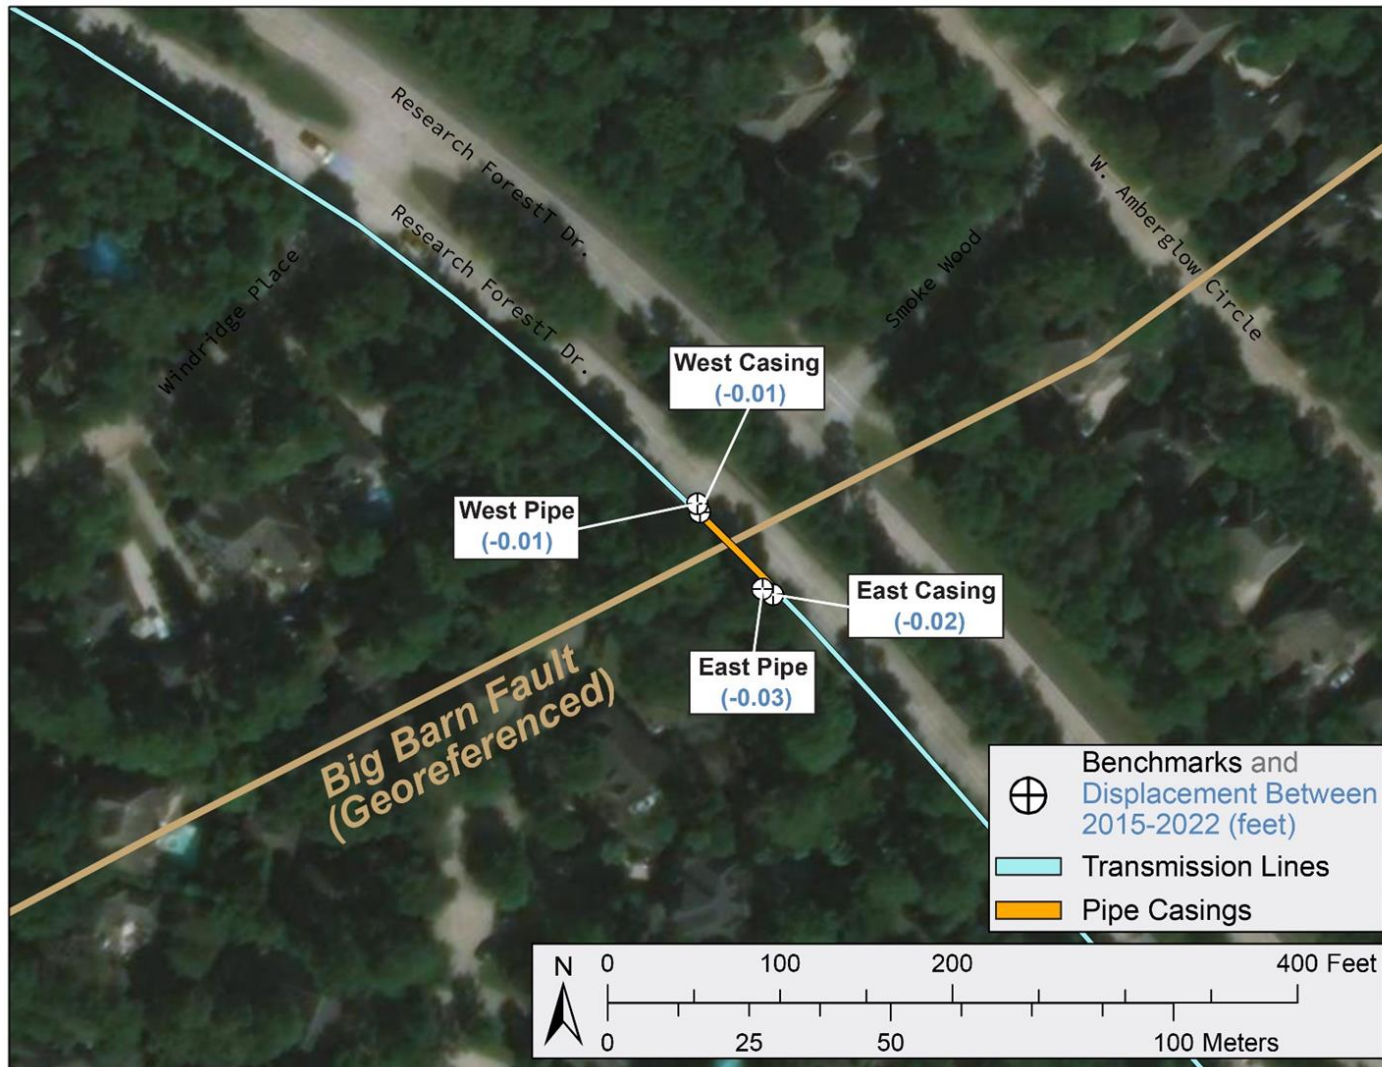
Big Barn Monitoring System - At the Big Barn Fault Monitoring System where four monitoring points on Research Forest Drive straddle the Big Barn Fault (Figure 4), the changes in the monitoring benchmark elevations indicate that a greater decrease in pipe/casing elevation has occurred on the downthrown side than on the upthrown side of the Big Barn Fault. Based on the change in elevations of the four monitoring benchmarks over an 8.5-year period from March 2015 to September 2023, the pipe/casing elevation on downthrown side of the Big Barn Fault decreased 0.020 ft relative to the upthrown side of the Big Barn Fault. The 0.020 ft decrease in pipe/casing over an 8.5-year period translates into average subsidence rate of approximately 0.0023 ft/yr.

The changes in the elevation of monitoring points that straddle the Big Barn Fault indicate that the downthrown side of the fault has subsided approximately 0.02 ft more than the upthrown side of the fault. A 0.02 ft decrease in elevation over 8.5 years translates into an average subsidence rate of approximately 0.0002 ft/yr.

Figure 4 Satellite map showing the location the Big Barn Fault (Fugro, 2012), the Big Barn Fault Monitoring System, calculated vertical displacement from March 2015 to September 2023, and the SJRA water line and pipe casing.

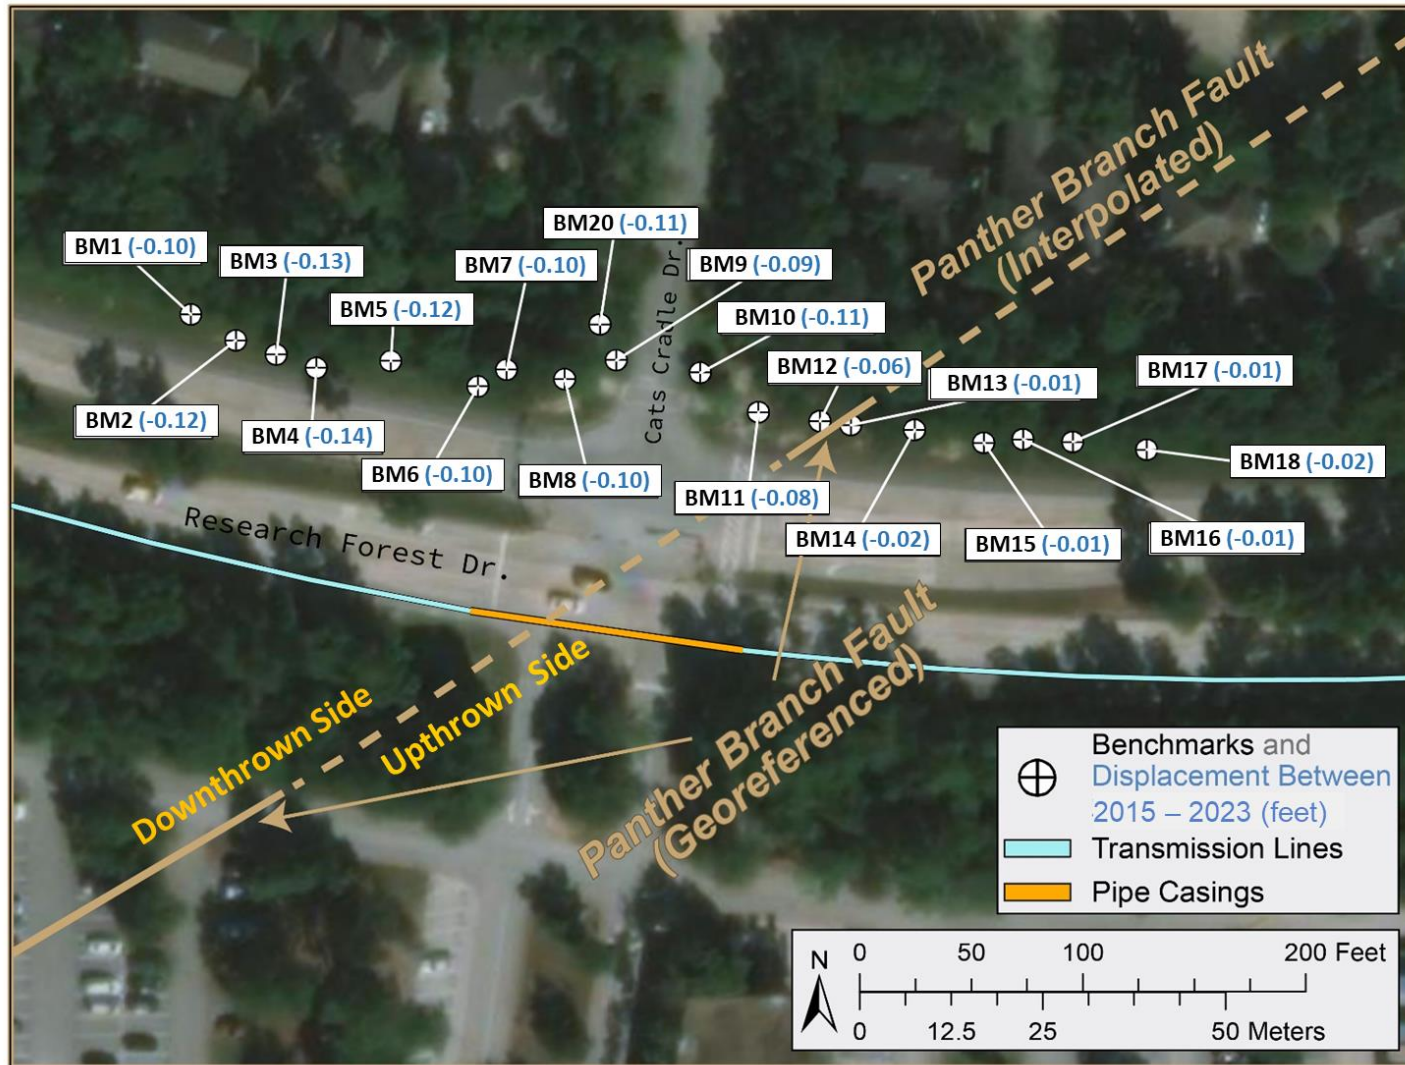
Figure 5

W2A Segment - Along the W2A segment where 19 monitoring benchmarks on Research Forest Drive are located near the suspected Panther Branch Fault (Figure 5), the changes in the monitoring benchmark elevations suggest that greater land subsidence has occurred on the downthrown side than on the upthrown side of the suspected Panther Branch Fault. Based on the change in elevations of the 19 monitoring benchmarks over an 8.5-year period from March 2015 to September 2023, the land surface on downthrown side of the suspected Panther Branch Fault decreased 0.084 ft in elevation relative to the upthrown side of the suspected Panther Branch Fault. The 0.084 ft decrease in land elevation over an 8.5-year period translates into an average subsidence rate of approximately 0.0099 feet per year (ft /yr).

The changes in the elevation for the monitoring benchmarks near the suspected Panther Branch Fault indicate that the downthrown side of the fault has subsided approximately 0.091 ft more than the upthrown side of the fault. The 0.091 ft decrease in elevation over 8.5 years translates into an average subsidence rate of approximately 0.0107 ft/yr since March 2015.

Because the Fugro report (2012) did not show that the suspected Panther Branch Fault crossing the water line, SJRA's consultant did not design nor did SJRA's contractor construct safeguards to protect the water line from differential subsidence associated with the suspected Panther Branch Fault. The average change in the monitoring benchmark elevations at the suspected Panther Branch Fault over 8.5 years for the upthrown side and for the downthrown side of the Big Barn Fault are a decrease of 0.013 ft in elevation and a decrease of 0.105 ft in elevation, respectively. Thus, the decrease of the downthrown side of the fault relative to the upthrown side is about 0.092 ft over 8.5 years, or approximately 0.0108 ft/yr. Figure 7 shows that since March 2022, the rate is 0.036 ft/yr. Per discussion with SJRA, SJRA plans to continue to monitor subsidence using the benchmarks associated with the Segment W2A Monitoring System and to investigate what safeguards may be needed to protect the transmission line. In addition, INTERA suggests that SRJA consider investigating a possible correlation between changes in seasonal pumping rates or in weather conditions during the recent hot and dry summers in 2022 and 2023 and the accelerated subsidence rates during those two summers.

Satellite map showing the location the suspected Panther Branch Fault mapped by INTERA, the Segment W2A Monitoring System, calculated vertical displacement from March 2015 to September 2023, and the SJRA water line and pipe casing.

Based on the changes in monitoring benchmark elevations and benchmark points during the last 8.5 years, the SJRA GRP water line is not at risk of damage from land subsidence where it crosses the Egypt Fault and the Big Barn Fault for the next 50 years if land subsidence continues at its current rate and if the consultant's safeguards work as designed. For the suspected Panther Branch Fault, the amount of subsidence that has occurred since March 2015 does not pose a threat to the safety of water line based on INTERA's discussion with SJRA consultants who designed the water line. However, INTERA recommends SJRA continue with studies of the suspected Panther Branch Fault study to determine if and

where the suspected Panther Branch Fault crosses the SJRA GRP water line and whether or not mitigation measures will be needed in future.

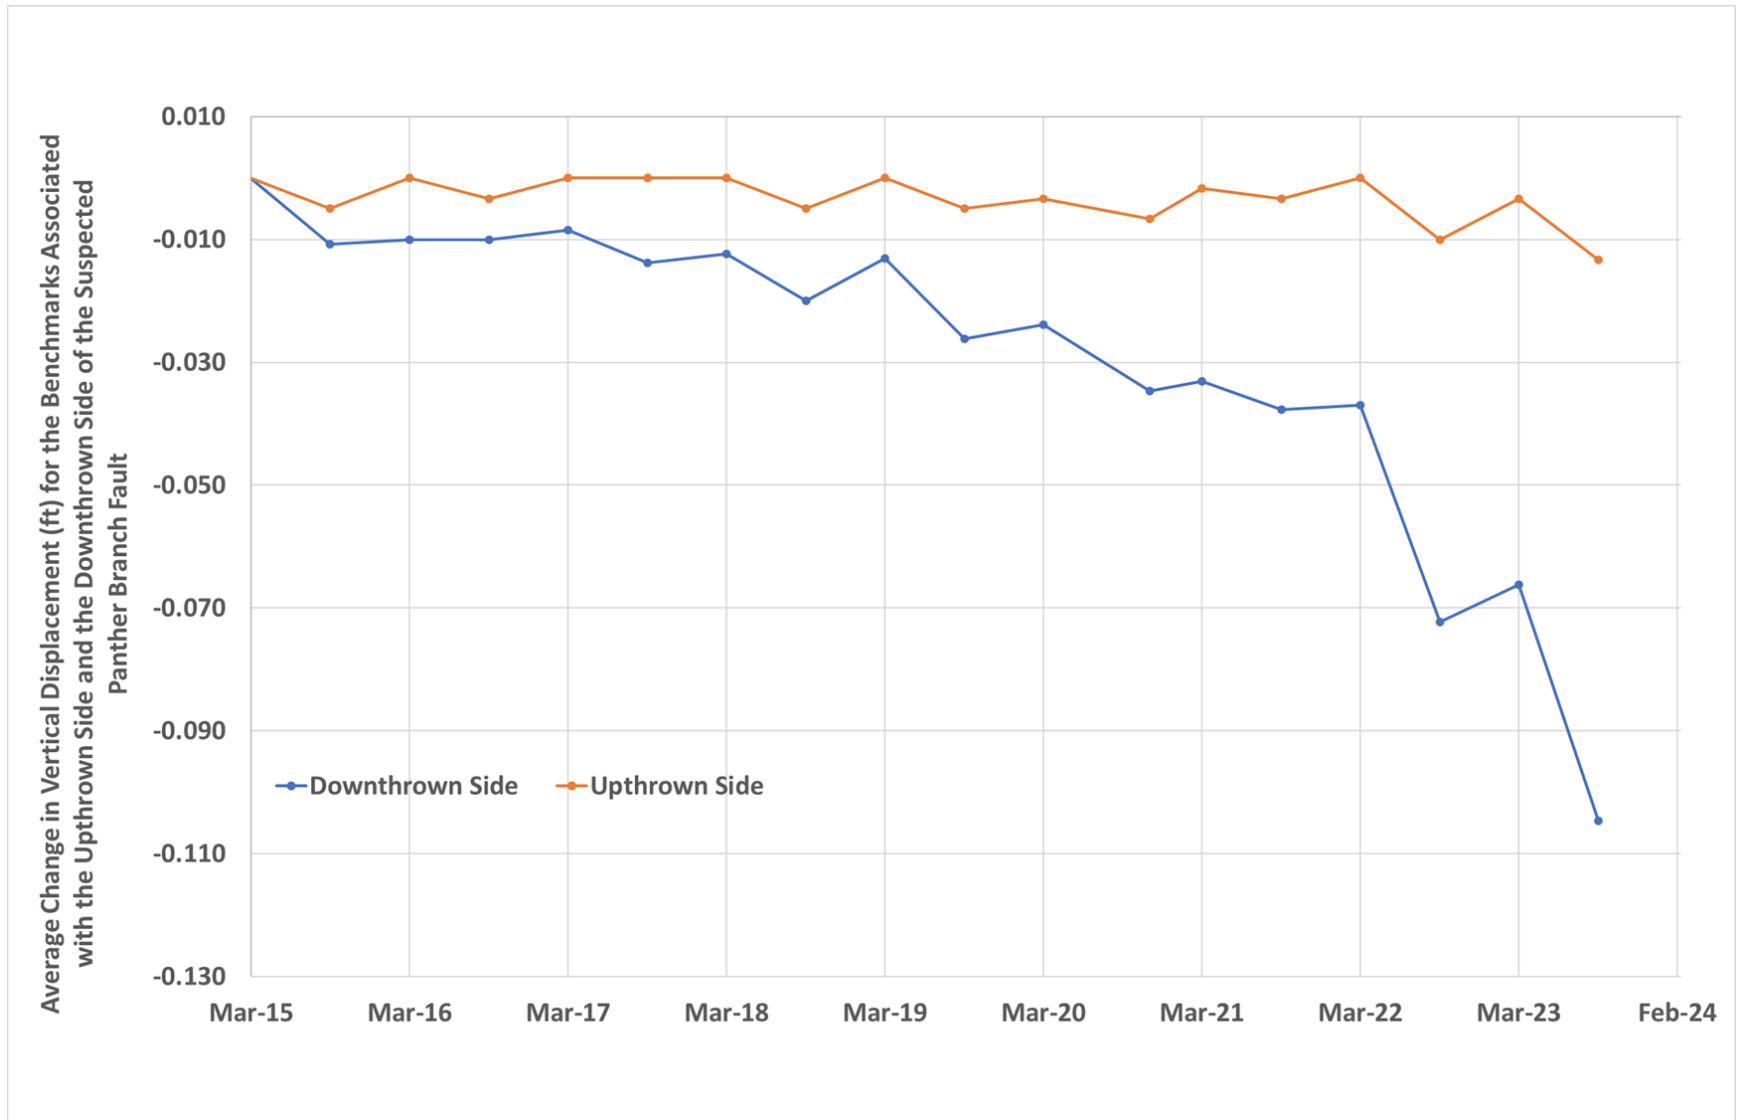
**Figure 6** shows graphs for the average vertical displacement calculated for the benchmarks located on the upthrown side and the downthrown side of the suspected Panther Branch Fault as a function of time since March 2015. The graphs show that the downthrown side of the fault has consistently greater decrease in elevation than does the upthrown side. Whereas the upthrown side of the fault has not subsided more than 0.01 ft over a 6-month period within the 8.5-year monitoring period, the downthrown side of the fault has exhibited a general trend of declining elevation with greater displacement rates at later times.

Figure 6 Comparison of average vertical displacement for the benchmarks located on the upthrown side and the downthrown side of the suspected Panther Branch Fault associated with the Segment W2A Monitoring System.

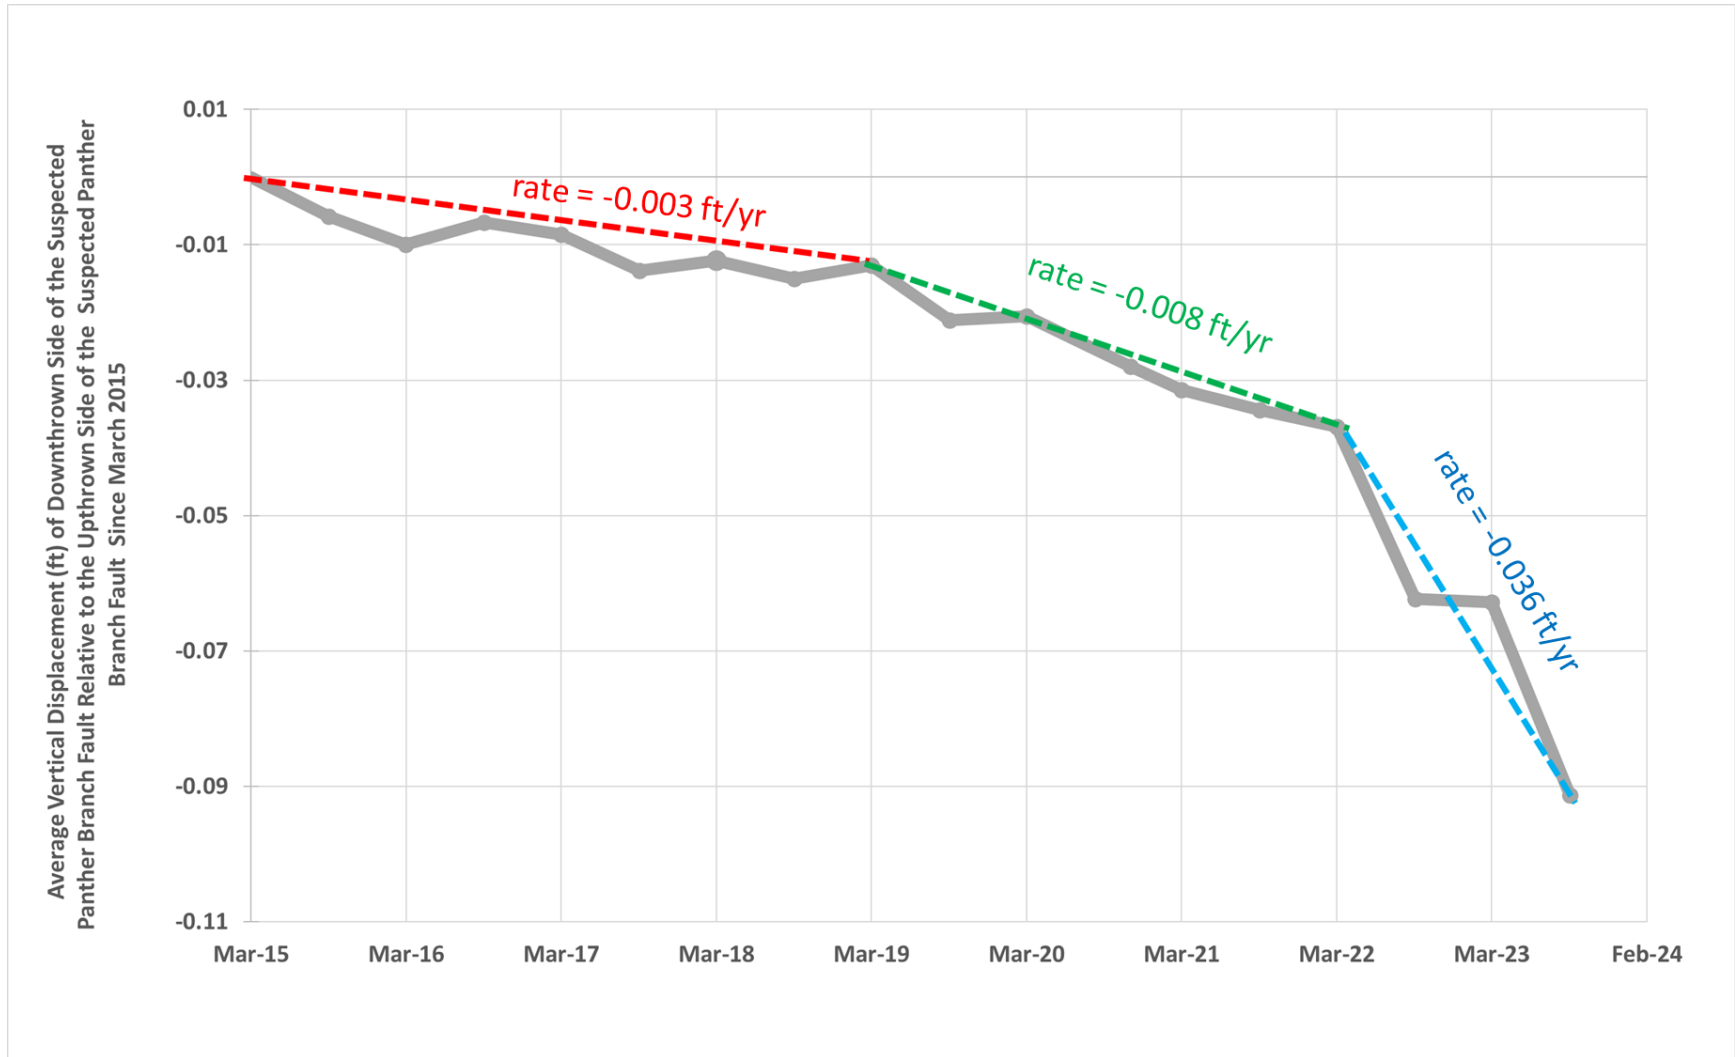
**Figure 7** and **Table 5** show the rates of vertical displacement for the downthrown side of suspected Panther Branch Fault relative to the upthrown side of the suspected Panther Branch Fault. The relative rate is calculated by subtracting the rate of displacement of the upthrown side from the rate of displacement of the downthrown side. The temporal changes in the displacement can be characterized into three periods: 1) from March 2015 to March 2019 the rate of vertical displacement averaged 0.0033 ft/yr downward; 2) from March 2019 to March 2022, the vertical displacement rate averaged 0.008 ft/yr downward; and 3) from March 2022 to September 2023, the vertical displacement rate averaged 0.036 ft/yr downward.

Figure 7 Relative vertical displacement and rates for relative vertical displacement for the downthrown side of the suspected Panther Branch Fault based on benchmarks associated with the Segment W2A Monitoring System
