SJRA SEGMENT W1A GEOLOGICAL MONITORING SURVEY

DATE: FEBRUARY 27, 2015
 SCALE: 1" = 20'
 DRAWING No.: 2038-D-
 JOB No.: 1420224, 2020163 & 2220031
 SHEET No.: 1 OF 1

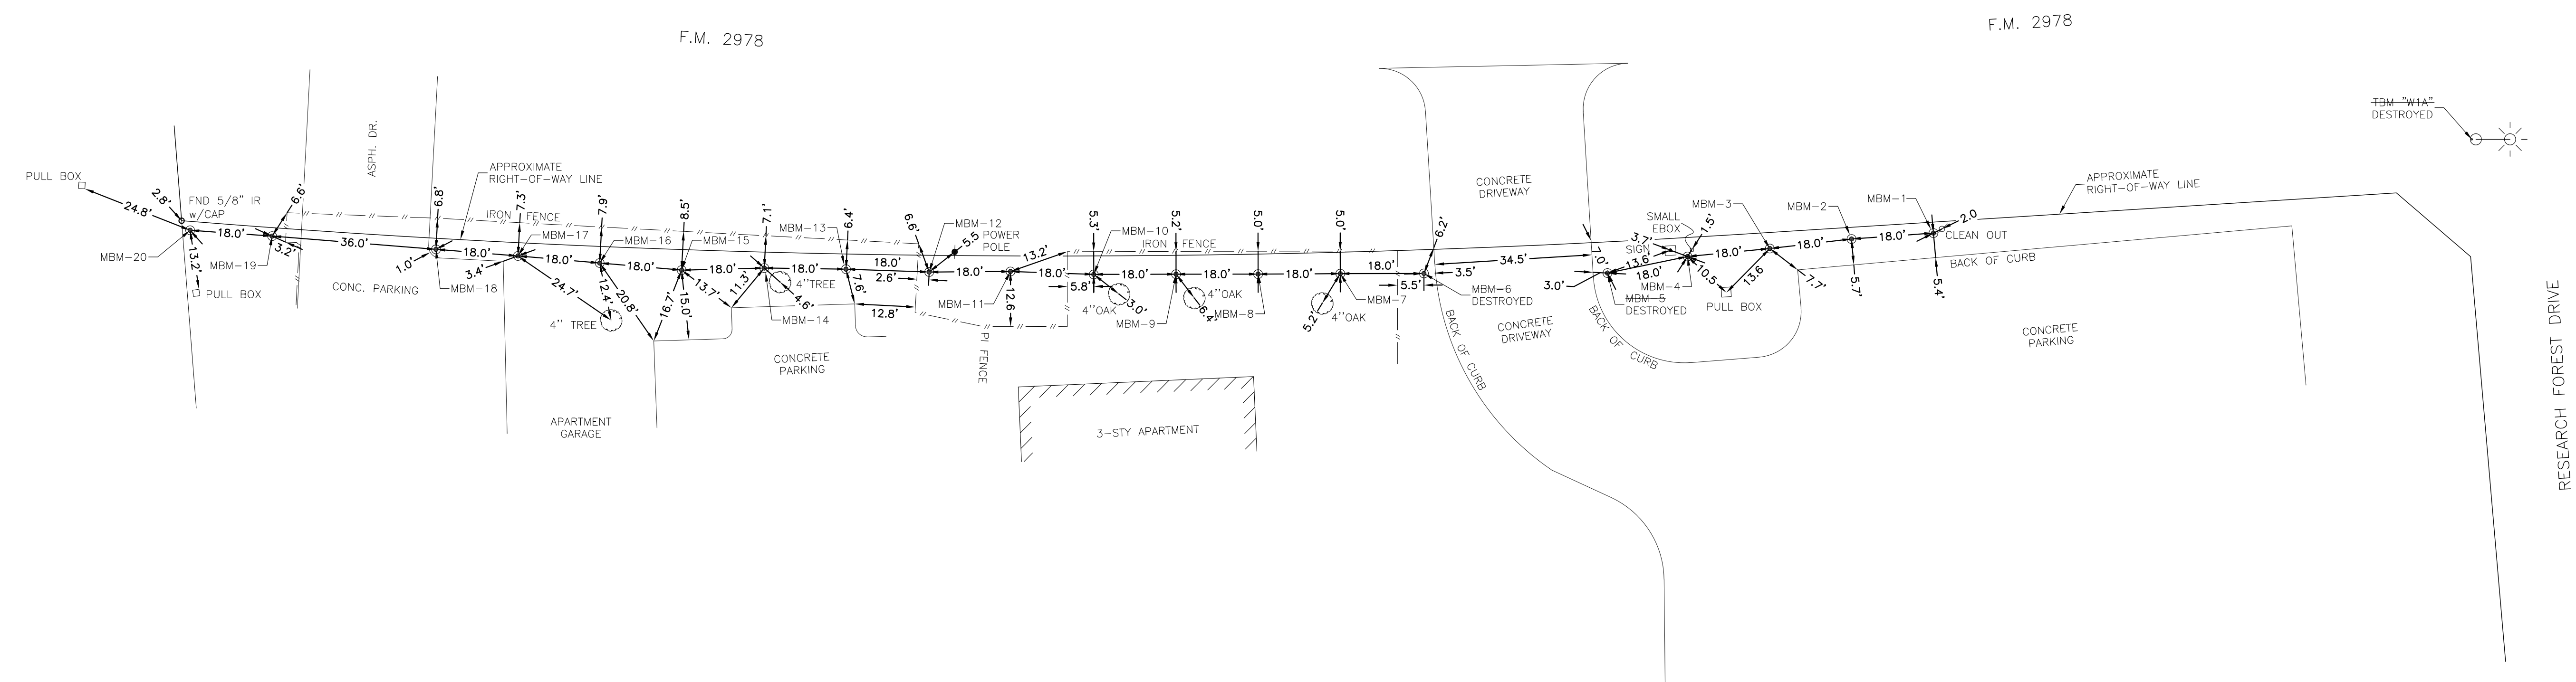
MBM- MONITORING BENCHMARK
 ● 1/2 INCH IRON ROD 4 FEET LONG
 INSIDE 4 INCH PVC SLEEVE WITH CAP
 COUNTERSUNK 4 TO 6 INCHES

MBM "W1A" DESTROYED SEE NOTE 2.
 Top of South Bolt on Signal Light Pole at the southeast corner of Research Forest Drive and FM 2978.
 Elevation = 195.68' (SJRA Project Vertical Control Datum)

- NOTES:
- All elevations are referenced to the SJRA Groundwater Reduction Plan Project Vertical Control Datum. Project Benchmark: SJRA Benchmark No. 5, Elevation = 212.00 feet.
 - MBM "W1A" was destroyed between September, 2018 and March, 2019, due to the construction of new road widening at the intersection of FM 2978 and Research Forest Drive. SJRA BM 30 has been observed throughout the monitoring and will be used for benchmark for the remaining duration. Refer to SJRA GRP Program Survey Monumentation System handbook for BM 30.
 - MBM-5 & MBM-6 were destroyed between March, 2020 and November, 2020 by the construction of a new driveway.
