April 29, 2022

**RE: Review of Fourteenth (14<sup>th</sup>) Re-measure of Elevations at Monitoring Benchmarks and Monitoring Points Along the Water Line Segments W1A and W2A in the Woodlands, Texas and Evaluation of Potential Damage to the Water Line along Segments W1A and W2A from Land Subsidence**

### Review of Fourteenth (14th) Re-measure of the Elevations at Monitoring Points and Monitoring Benchmarks along Water Line Segments W1A and W2A

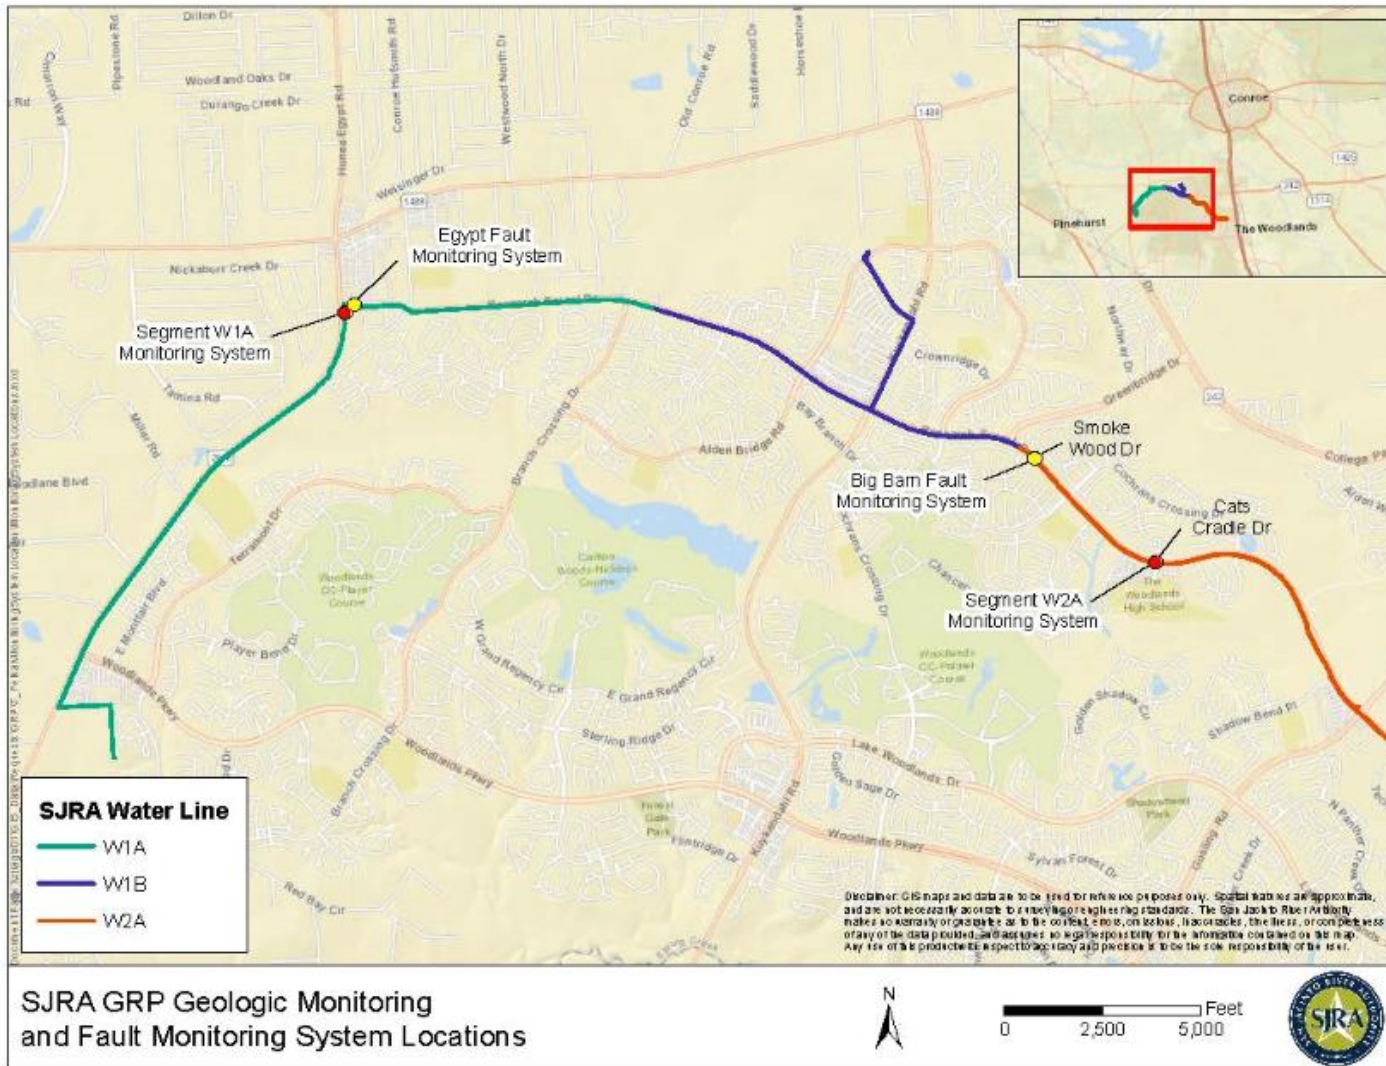
Figure 1 SJRA Groundwater Reduction Plan (GRP) Fault Monitoring System Locations (<https://www.sjra.net/grp/fault-monitoring/>)

The fourteenth re-measure includes measurements of elevations monitoring points and monitoring benchmarks along the water line segments W1A and W2A in March 2022. **Figure 1** shows the locations of the water line segments W1A and W2A and the four monitoring systems. Each of the monitoring systems consist of monitoring points or monitoring benchmarks. Monitoring benchmarks terminate in the ground and are used to measure elevation changes in the soil. Monitoring points terminate on top of a pipe or a pipe casing and are used to measure the elevation changes of the waterline. The Egypt Fault Monitoring System and the Big Barn Fault Monitoring System consists only of monitoring points. The Segment W1A Monitoring System and Segment W2A Monitoring System consists of only monitoring benchmarks.

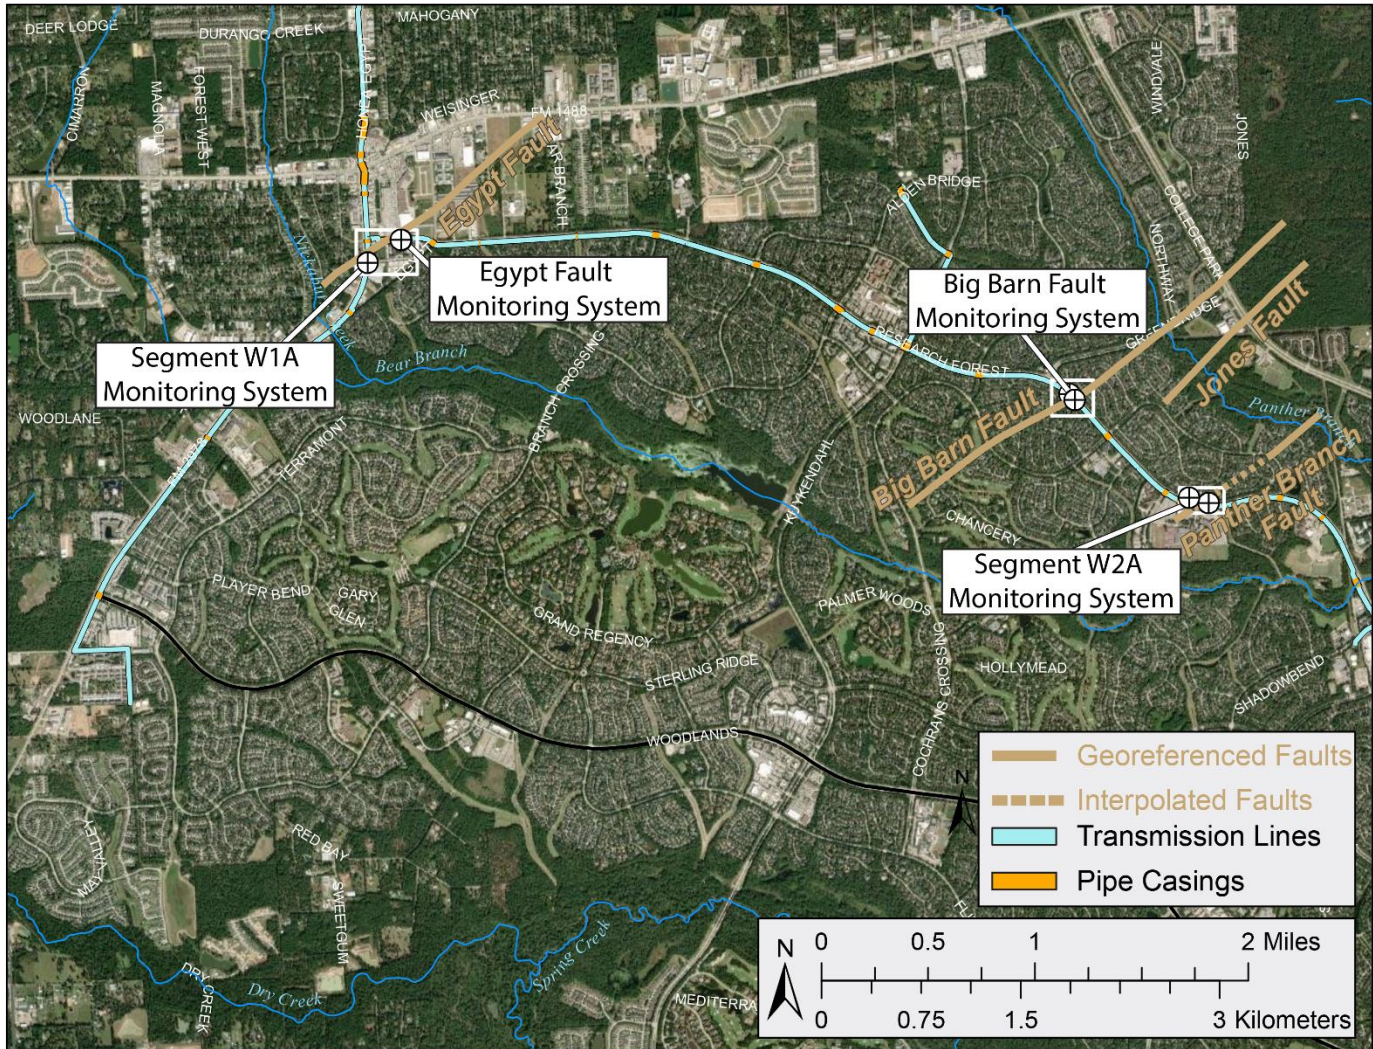
Figure 2 Satellite map showing the location of the SJRA water line, the fault locations mapped by Fugro (2012), and SJRA monitoring systems

**Figure 2** is a satellite map that shows the San Jacinto River Authority (SJRA) water line and the faults that have been identified in the vicinity of waterline segments W1A and W2A by Fugro (2012). The lateral extent of the Egypt, Big Barn, Jones, and Panther Branch faults mapped by Fugro (2012) are represented by the georeferenced fault lines. In their study, Fugro (2012) did not extend the Panther Branch Fault across the SJRA water line route. INTERA mapped the interpolated portion of the Panther Branch Fault in **Figure 2** in 2021 based on an evaluation of the monitoring benchmark elevation for Segment W2A and scarp locations in the parking lot of The Woodlands High School.
