RE: Review of Sixteenth(16th) Re-measure of Elevations at Monitoring Benchmarks and Monitoring Points Along the Water Line Segments W1A and W2A in the Woodlands, Texas

Review of Sixteenth (16th) Re-measure of the Elevations at Monitoring Points and Monitoring Benchmarks along Water Line Segments W1A and W2A

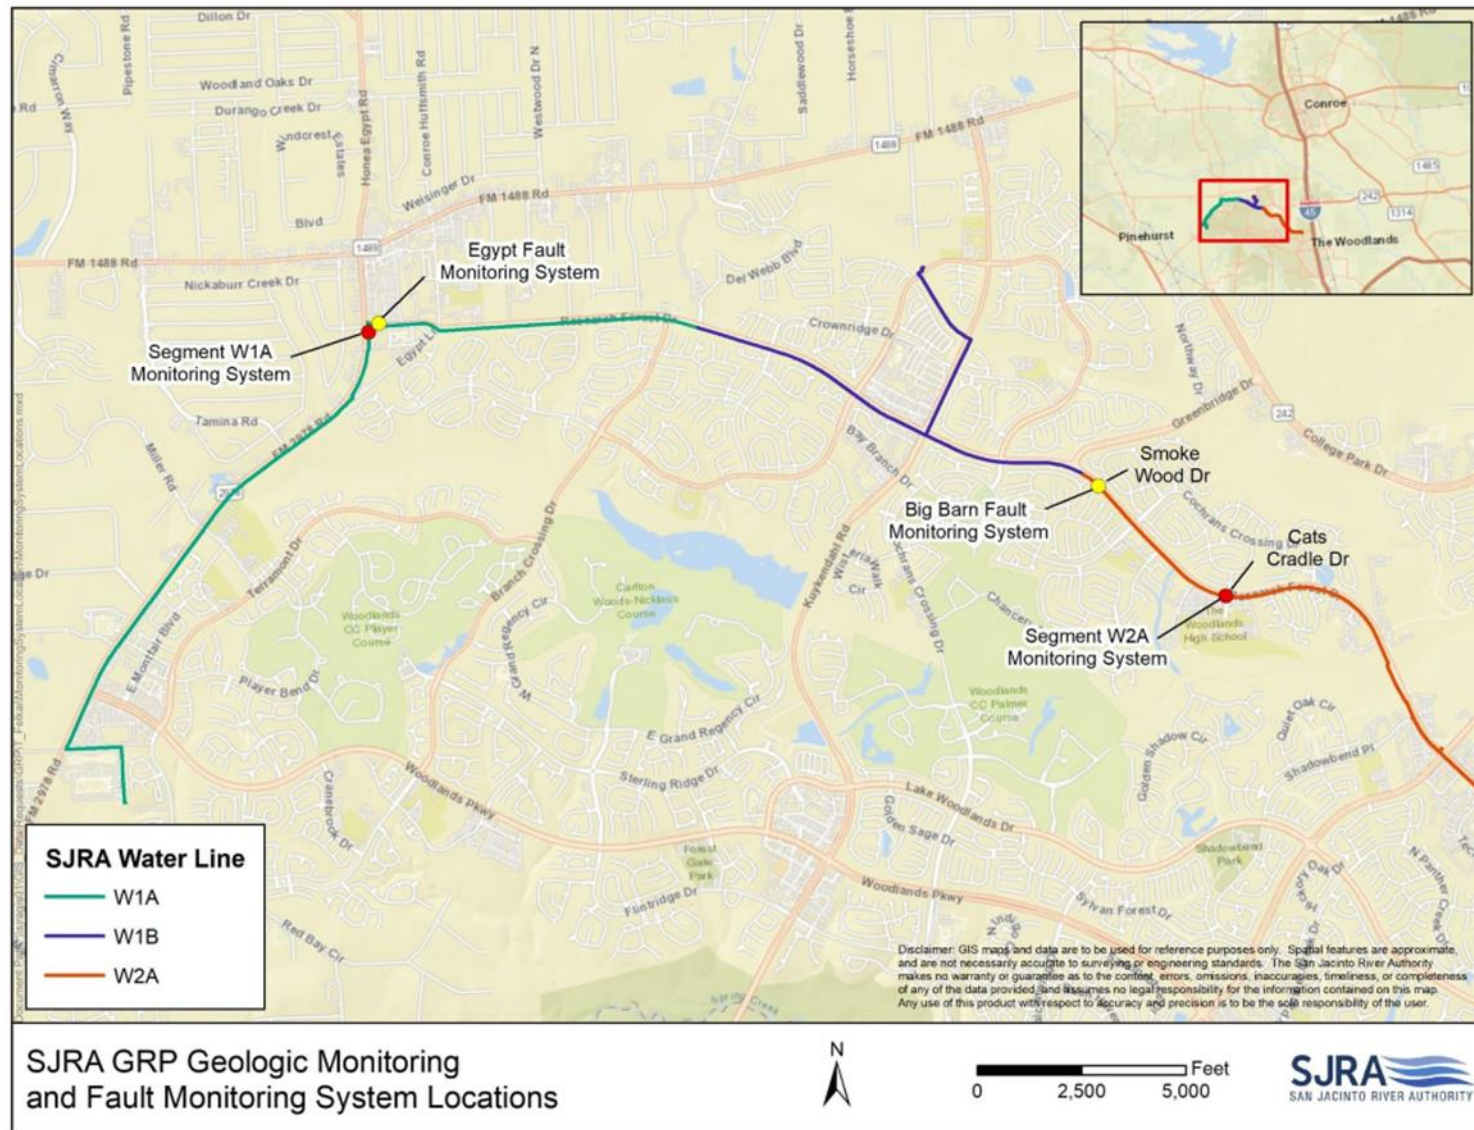
Figure 1 SJRA Groundwater Reduction Plan (GRP) Fault Monitoring System Locations (<https://www.sjra.net/grp/fault-monitoring/>)

The sixteenth re-measure includes measurements of elevations monitoring points and monitoring benchmarks along the water line segments W1A and W2A in March 2023. **Figure 1** shows the locations of the water line segments W1A and W2A and the four monitoring systems. Each of the monitoring systems consist of monitoring points or monitoring benchmarks. Monitoring benchmarks terminate in the ground and are used to measure elevation changes in the soil. Monitoring points terminate on top of a pipe or a pipe casing and are used to measure the elevation changes of the water line. The Egypt Fault Monitoring System and the Big Barn Fault Monitoring System consists only of monitoring points. The Segment W1A Monitoring System and Segment W2A Monitoring System consists of only monitoring benchmarks.

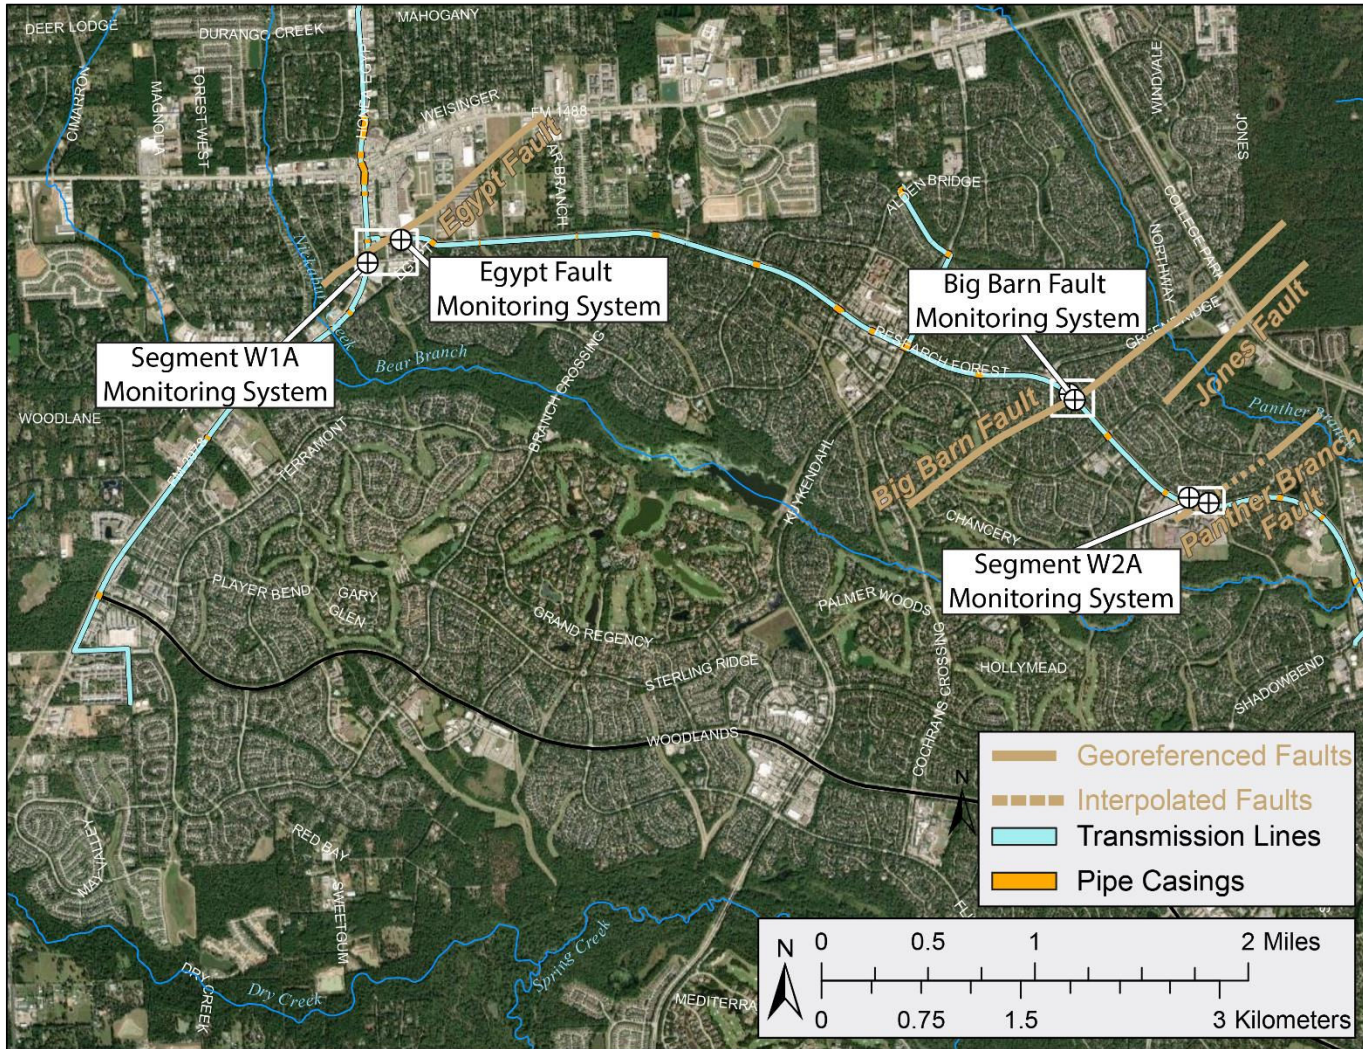
Figure 2 Satellite map showing the location of the SJRA water line, the fault locations mapped by Fugro (2012), and SJRA monitoring systems

Figure 2 is a satellite map that shows the San Jacinto River Authority (SJRA) GRP water line and the faults that have been identified in the vicinity of water line segments W1A and W2A by Fugro (2012). The lateral extent of the Egypt, Big Barn, Jones, and suspected Panther Branch faults reported by Fugro (2012) are represented by the georeferenced fault lines. In their study, Fugro (2012) did not extend the Panther Branch Fault across the SJRA GRP water line route. INTERA mapped the suspected interpolated portion of the Panther Branch Fault in Figure 2 in 2021 based on an evaluation of the monitoring benchmark elevation for Segment W2A and aerial photographs of scarp locations in the parking lot of The Woodlands High School.
