**RE: Review of Seventeenth (17th) Re-measure of Elevations at Monitoring Benchmarks and Monitoring Points Along the Water Line Segments W1A and W2A in the Woodlands, Texas**

### Review of Seventeenth (17th) Re-measure of the Elevations at Monitoring Points and Monitoring Benchmarks along Water Line Segments W1A and W2A

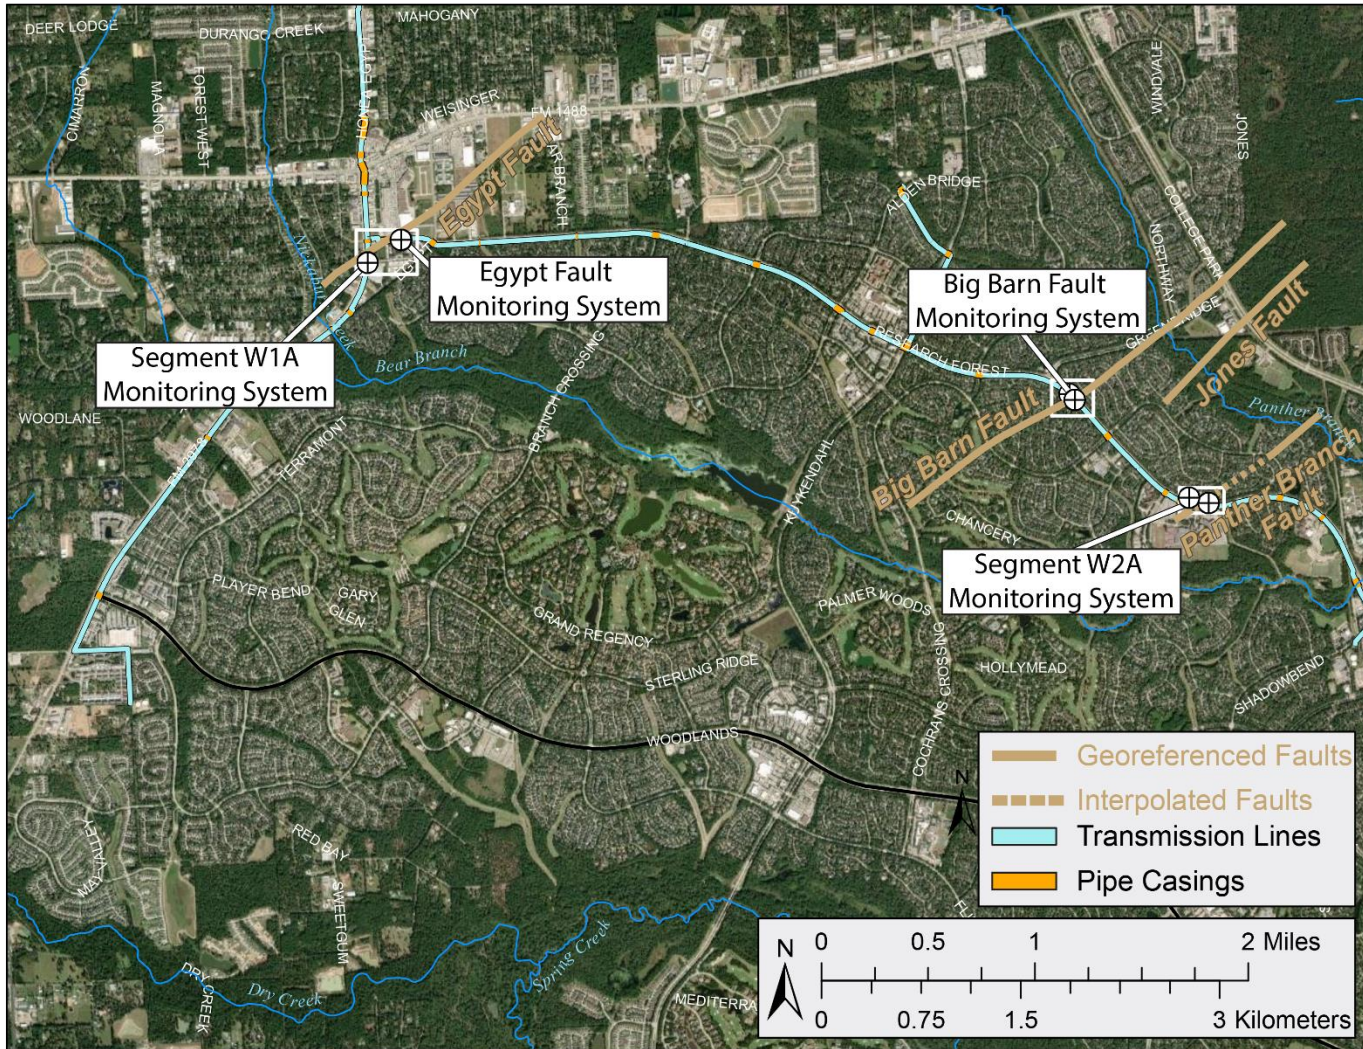
**Figure 2** is a satellite map that shows the San Jacinto River Authority (SJRA) GRP water line and the faults that have been identified in the vicinity of water line segments W1A and W2A by Fugro (2012). The lateral extent of the Egypt, Big Barn, Jones, and suspected Panther Branch faults reported by Fugro (2012) are represented by the georeferenced fault lines. In their study, Fugro (2012) did not extend the Panther Branch Fault across the SJRA GRP water line route. INTERA mapped the suspected interpolated portion of the Panther Branch Fault in Figure 2 in 2021 based on an evaluation of the monitoring benchmark elevation for Segment W2A and aerial photographs of scarp locations in the parking lot of The Woodlands High School.

Figure 2 Satellite map showing the location of the SJRA water line, the fault locations mapped by Fugro (2012), and SJRA monitoring systems.
